BUILDING-STRUCTURE INVENTORY FORM

YOUR NAME: BUFFALO FRIENDS OF OL MSTED PARKS DATE: March 30, 1984

- 1. BUILDING NAME(S): _____
- 2. COUNTY: Erie TOWN/CITY: Buffalo VILLAGE: _____
- 3. STREET LOCATION: 286 Woodward Ave
- 4. OWNERSHIP: a. public b. private
- 5. PRESENT OWNER: Lois Hubbard ADDRESS: 286 Woodward
- 6. USE: Original: Residential Present: Residential
- 7. ACCESSIBILITY TO PUBLIC: Exterior visible from public road: Yes No
Interior accessible: Explain by permission

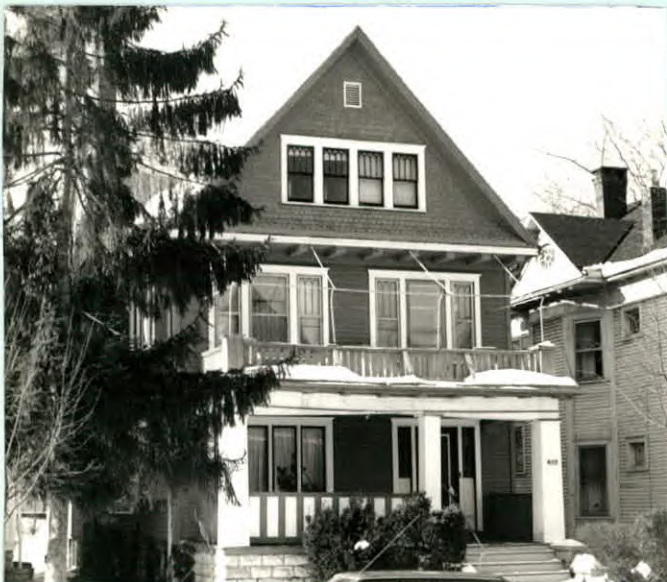
12. PHOTO: 21-28a

Porch is a later addition. First floor window, lights altered.

Two and a half story with Colonial Revival style details. Front facing gable roof. Full-width porch has tapered square supports, paneled balustrade. Modillion blocks under cornice. Upper porch stick balustrade. Glass paneled door with leaded sidelights. Tri-part single light window on first floor. Second story has pair of

SIGNIFICANCE tri-part windows, single light with transom center with
 19. DATE OF INITIAL CONSTRUCTION: 1912 sidelights having arched
 tracery. Projecting pedimented
 gable with supporting brackets.

ARCHITECT: _____
Fish-scale shingles. Four-part window, has arched
 BUILDER: _____
tracery in top lights. Entablature window and
door surrounds.
