BUILDING-STRUCTURE INVENTORY FORM

1. BUILDING NAME(S): _____
2. COUNTY: Erie TOWN/CITY: Buffalo VILLAGE: _____
3. STREET LOCATION: 297 Woodward Ave
4. OWNERSHIP: a. public b. private
5. PRESENT OWNER: Basil Tzitzis ADDRESS: 297 Woodward
6. USE: Original: Residential Present: Residential
7. ACCESSIBILITY TO PUBLIC: Exterior visible from public road: Yes No
 Interior accessible: Explain by permission

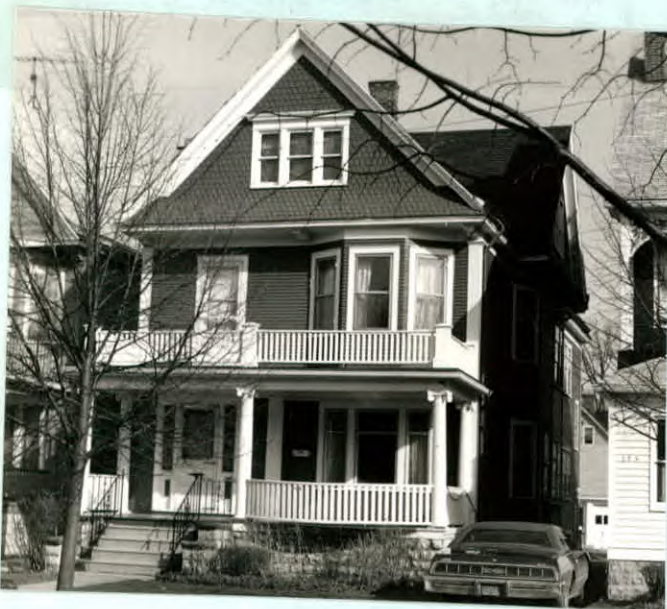
12. PHOTO: 24-22a

Two and a half story Colonial Revival style. Front facing gable roof. Full-width porch has fluted Ionic columns and curved stick balustrade. Projecting cornice. Upper porch stick balustrade. Glass paneled door with sidelights. Tri-part first floor window, single light with transom. Second story semi-hexagonal bay window,

SIGNIFICANCE 1/1 light square-headed windows. Glass paneled porch door. Pedimented projecting gable with supporting ancones. Tri-part window, 1/1 lights has entablature with crowning cornice surround. Fluted building end pilaster strips.

20. HISTORICAL AND ARCHITECTURAL IMPORTANCE: Typical urban Colonial Revival style house. Curved balustrade and Ionic columns in porch distinguish this house from others of similar style. Woodward Avenue runs parallel to Parkside Avenue and extends from Humboldt Avenue to the northwest portion of Crescent Avenue. This street appears on Olmsted's early 1870's maps of "The Parkside," although it is less curvilinear than originally planned. Portions of Woodward Avenue (originally called Davis Avenue) were deeded to the city by five different owners between 1887 and 1892; except for the section north of Amherst, this was done when comparable sections of Crescent Avenue were deeded. Following Olmsted's rule for a suburban street, Woodward Avenue does "not lead with special directness toward town."
