BUILDING-STRUCTURE INVENTORY FORM

DIVISION FOR HISTORIC PRESERVATION
NEW YORK STATE PARKS AND RECREATION
ALBANY, NEW YORK (518) 474-0479

- BUILDING NAME(S): _____
- COUNTY: Erie TOWN/CITY: Buffalo VILLAGE: _____
- STREET LOCATION: 298 Woodward Ave
- OWNERSHIP: a. public b. private
- PRESENT OWNER: Earl Cantwell ADDRESS: 298 Woodward
- USE: Original: Residential Present: Residential
- ACCESSIBILITY TO PUBLIC: Exterior visible from public road: Yes No
Interior accessible: Explain by permission

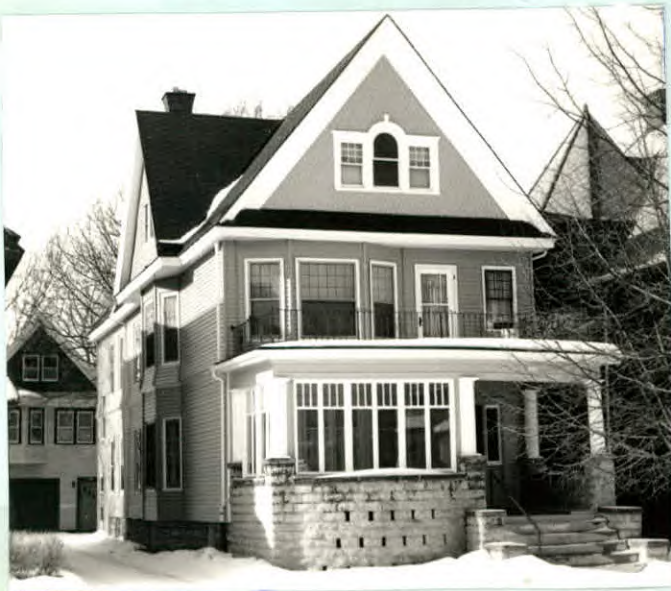
12. PHOTO: 21-31a & 21-32a

Two and a half story with Colonial Revival style details. Front facing gable roof. Full-width porch partially enclosed. Horizontal band of windows, single light with 3 vertical light transoms. Rough cut, regular course stone base. Half fluted Doric column supports. Entablature with projecting cornice. Wood paneled door flanked by SIGNIFICANCE sidelights. Second story semi-hexagonal bay window with center window 18/1 lights and 9/1 side windows. Porch door, multi-light. Pedimented gable, shingled, has palladian window.
