A COLORED AND A COLOR
DUIL DINC STRUCTURE INVENTORY FORM	FOR OFFICE USE ONLY
BUILDING-STRUCTURE INVENTORY FORM	020 10 00
DIVISION FOR HISTORIC PRESERVATION	UNIQUE SITE NO. 9-40 5716
NEW YORK STATE PARKS AND RECREATION	QUAD
ALBANY, NEW YORK (518) 474-0479	SERIES
ALDAN 1, NEW TORK (518) 4/4-04/9	NEG. NO
YOUR NAME: BUFFALO FRIENDS OF OLMSTED PARE	(S) DATE: March 30, 1984

I. BUILDING NAME (S):	
2. COUNTY: Erie TOWN/CITY: H	SUITALOVILLAGE:
3. STREET LOCATION: <u>304 Woodward A</u>	VO
4. OWNERSHIP: a. public b. private	
5. PRESENT OWNER: John Simon	ADDRESS: <u>304 Woodward</u>

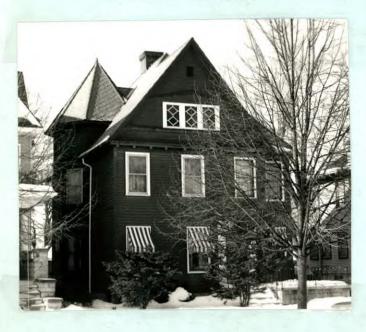
12. PHOTO: 21-33a

e. other	
0. CONDITION: a. excellent 🗌 b. good 🗵 c	. fair 🗌 d. deteriorated 🗌
	if so, when?
c. list major alterations and dates (if	known):
Porch removed

18. OTHER NOTABLE FEATURES OF BUILDING AND SITE (including interior features if known): Two and a half story later, simplified form of the Queen Anne style. Hip roof. Steep-pitched gabled wing has brackets under eave. Wood paneled door with entablature door surround. Dentils under cornice. Leaded window to right of entrance. First and second floor 1/1 light windows. Gable has false pediment with dentils. Tri-part window with decorative diamondshaped tracery. Threestory semi-hexagonal bay

ARCHITECT:	with polygonal tent roof
	on south side.
