BUILDING-STRUCTURE INVENTORY FORM

DIVISION FOR HISTORIC PRESERVATION
NEW YORK STATE PARKS AND RECREATION
ALBANY, NEW YORK (518) 474-0479

- BUILDING NAME(S): _____
- COUNTY: Erie TOWN/CITY: Buffalo VILLAGE: _____
- STREET LOCATION: 305 Woodward Ave
- OWNERSHIP: a. public b. private
- PRESENT OWNER: Joseph Dagonese ADDRESS: 305 Woodward
- USE: Original: Residential Present: Residential
- ACCESSIBILITY TO PUBLIC: Exterior visible from public road: Yes No
Interior accessible: Explain by permission

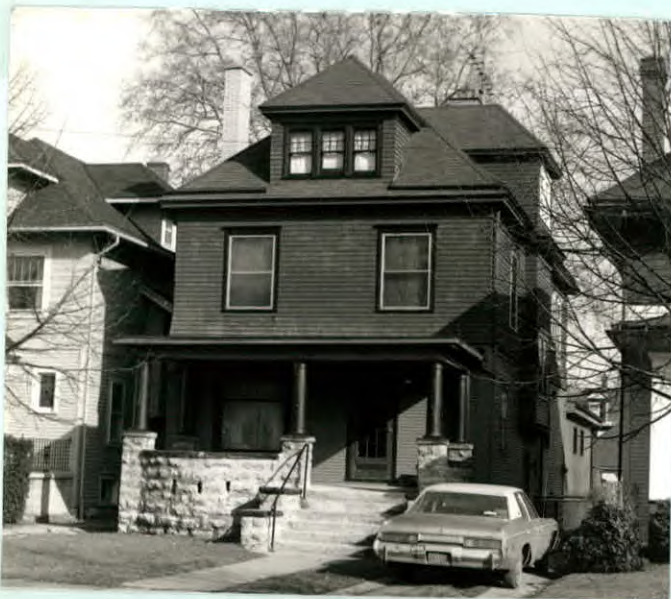
12. PHOTO: 24-25a

18. OTHER NOTABLE FEATURES OF BUILDING AND SITE (including interior features if known):
Two and a half story Colonial Revival style. Hip roof. Full-width porch has bowed base, rough cut, regular course stone. Doric columns support entablature. Glass paneled door. First floor single light with transom. Second floor has 1/1 light windows. Entablature window surround. Hip roof dormer has SIGNIFICANCE three 6/1 light windows.
