**BUILDING-STRUCTURE INVENTORY FORM**

1. BUILDING NAME(S): \_\_\_\_\_
2. COUNTY: Erie TOWN/CITY: Buffalo VILLAGE: \_\_\_\_\_
3. STREET LOCATION: 316 Woodward Ave
4. OWNERSHIP: a. public  b. private
5. PRESENT OWNER: David Vdin ADDRESS: 316 Woodward
6. USE: Original: Residential Present: Residential
7. ACCESSIBILITY TO PUBLIC: Exterior visible from public road: Yes  No   
 Interior accessible: Explain by permission

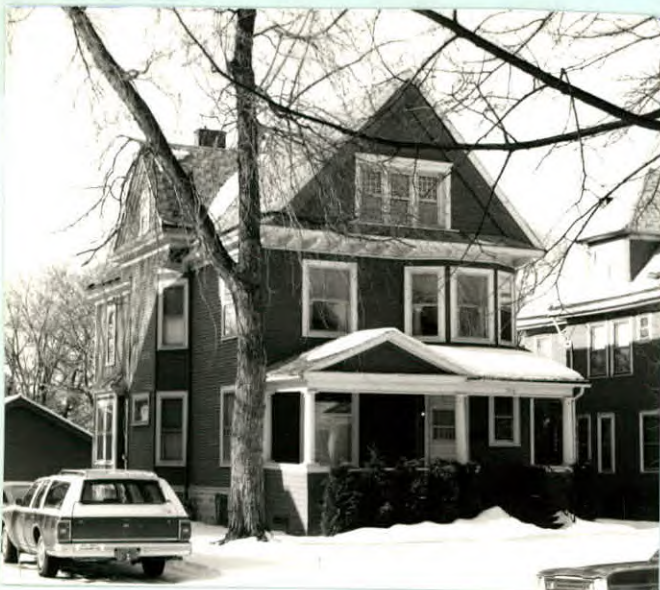
12. PHOTO: 21-36a

18. OTHER NOTABLE FEATURES OF BUILDING AND SITE (including interior features if known):  
Two and a half story Colonial Revival style. Front facing gable roof. Shed roof full-width porch has pedimented gable end. Doric columns, fluted. Capitals decorated with bull's eye motif. Glass and wood paneled door. First floor window, single light with leaded transom. Second floor semi-hexagonal bay window, SIGNIFICANCE 1/1 lights. Pedimented gable has brackets under projection. Gable has 16/1 light windows, three.
19. DATE OF INITIAL CONSTRUCTION: 1896
