**BUILDING-STRUCTURE INVENTORY FORM**

- BUILDING NAME(S): \_\_\_\_\_
- COUNTY: Erie TOWN/CITY: Buffalo VILLAGE: \_\_\_\_\_
- STREET LOCATION: 324-326 Woodward Ave
- OWNERSHIP: a. public  b. private  1620 Action St.,
- PRESENT OWNER: Marie Gill ADDRESS: Berkeley, CA 94702
- USE: Original: Residential Present: Residential
- ACCESSIBILITY TO PUBLIC: Exterior visible from public road: Yes  No   
Interior accessible: Explain by permission

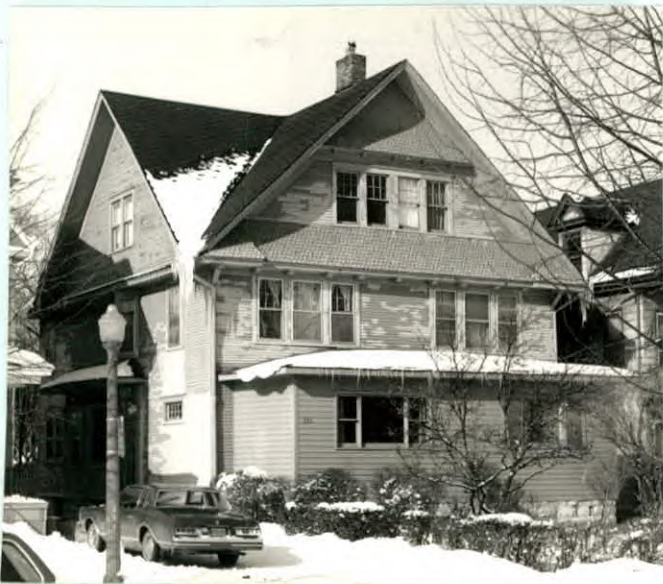
12. PHOTO: 22-1a

Two and a half story plain residential structure. Cross gable roof. Full-width hip roof wing has a pair of tri-part windows, single light with 1/1 sidelights. Second floor has a pair of tri-part 6/1 windows. Pedimented gable with brackets under projecting eave. Fish scale shingles at base and top of gable.

SIGNIFICANCE Four-part 6/1 window. South entrance has multi-light window with 4-light transom,

19. DATE OF INITIAL CONSTRUCTION: 1910 and semi-hexagonal hip roof bay flanking.
