**BUILDING-STRUCTURE INVENTORY FORM**

- BUILDING NAME(S): \_\_\_\_\_
- COUNTY: Erie TOWN/CITY: Buffalo VILLAGE: \_\_\_\_\_
- STREET LOCATION: 371 Crescent Ave
- OWNERSHIP: a. public  b. private
- PRESENT OWNER: Joseph Weiss ADDRESS: 478 Starin, Buffalo, NY
- USE: Original: Residential Present: Residential 14216
- ACCESSIBILITY TO PUBLIC: Exterior visible from public road: Yes  No   
Interior accessible: Explain by permission

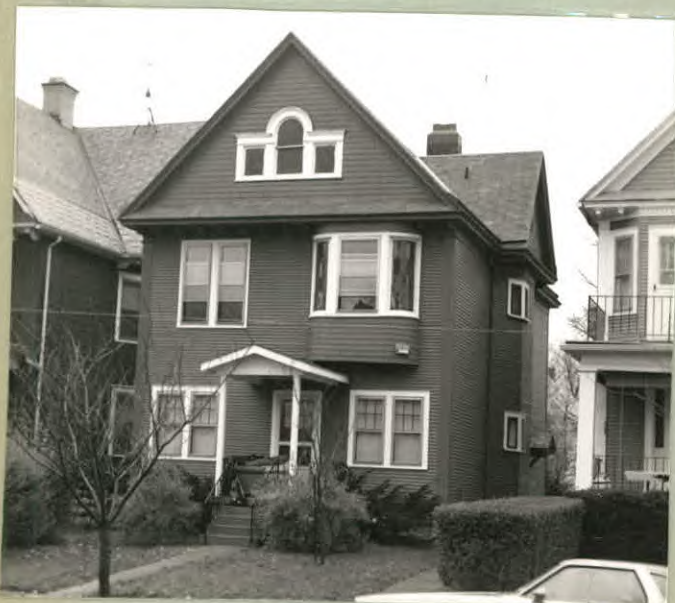
12. PHOTO: 5-12a & 19-6a

18. OTHER NOTABLE FEATURES OF BUILDING AND SITE (including interior features if known):  
Two and a half story Colonial Revival style. Front-facing gable roof. Pedimented gable entrance porch with slender supports. Six-light wood paneled door. First floor had paired 6/1 windows. Second floor bowed oriel, shingled, with 1/1 center window and leaded sides. Second floor paired 1/1 windows. End fluted doric pilaster strips. Pedimented gable has brackets under projection. Shingled.
