BUILDING-STRUCTURE INVENTORY FORM

1. BUILDING NAME(S): _____
2. COUNTY: Erie TOWN/CITY: Buffalo VILLAGE: _____
3. STREET LOCATION: 343 Woodward Ave
4. OWNERSHIP: a. public b. private
5. PRESENT OWNER: John P. Daley ADDRESS: 343 Woodward
6. USE: Original: Residential Present: Residential
7. ACCESSIBILITY TO PUBLIC: Exterior visible from public road: Yes No
 Interior accessible: Explain by permission

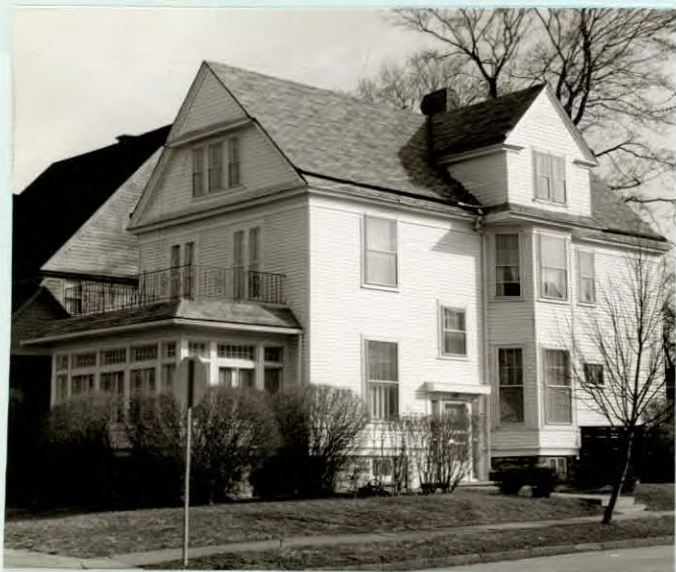
12. PHOTO: 24-33a

Two and a half story with Colonial Revival style details. Side gable roof. Wood paneled door with sidelights. Cornice hood. Semi-hexagonal two story bay. First and second floor square-headed, 6/1 and 8/1 light windows. Dentils under roof eave. Gable dormer with cornice end return. Pair of 12/1 light windows. North side has full-width wing. Deck roof. Horizontal

19. DATE OF INITIAL CONSTRUCTION: c. 1886
ARCHITECT: _____
BUILDER: double sash doors. Gable has tri-part window 12/1 lights. Crowning cornice.
