BUILDING-STRUCTURE INVENTORY FORM

UNIQUE SITE NO. 030-40 5726

1. BUILDING NAME(S): _____
2. COUNTY: Erie TOWN/CITY: Buffalo VILLAGE: _____
3. STREET LOCATION: 344 Woodward Ave
4. OWNERSHIP: a. public b. private
5. PRESENT OWNER: Mary Bush ADDRESS: 344 Woodward
6. USE: Original: Residential Present: Residential
7. ACCESSIBILITY TO PUBLIC: Exterior visible from public road: Yes No
 Interior accessible: Explain by permission

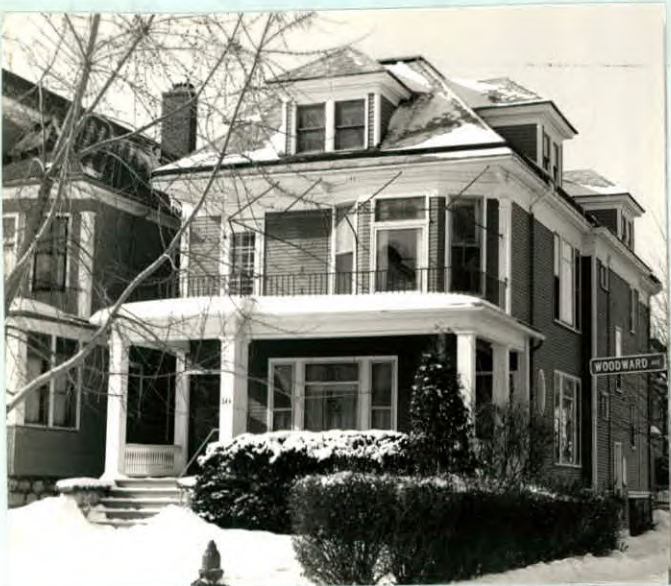
12. PHOTO: 22-6a

8. BUILDING MATERIAL: a. clapboard b. stone c. brick d. board and batten
 e. cobblestone f. shingles g. stucco other: _____
9. STRUCTURAL SYSTEM: a. wood frame with interlocking joints
 (if known) b. wood frame with light members
 c. masonry load bearing walls
 d. metal (explain) _____
 e. other _____
10. CONDITION: a. excellent b. good c. fair d. deteriorated
11. INTEGRITY: a. original site b. moved if so, when? _____
 c. list major alterations and dates (if known):
Upper porch balustrade altered

Two and a half story simplified form of Colonial Revival style. Hip roof with brackets under eave. Full-width porch has square supports, spindle balustrade, entablature. Glass panel door. Tri-part first floor window, single light with leaded transom center, 1/1 sidelights. Second floor semi-hexagonal bay with window pattern imitating first floor window. Multi-

19. DATE OF INITIAL CONSTRUCTION: 1904 Hip light porch door. Hip roof dormer has a pair of 1/1 light windows. Dentils under eave. Corner fluted Doric pilaster strips.
- ARCHITECT: _____
- BUILDER: _____
