BUILDING-STRUCTURE INVENTORY FORM

- 1. BUILDING NAME(S): \_\_\_\_\_
- 2. COUNTY: Erie TOWN/CITY: Buffalo VILLAGE: \_\_\_\_\_
- 3. STREET LOCATION: 379 Crescent Ave
- 4. OWNERSHIP: a. public  b. private
- 5. PRESENT OWNER: Charles Klauk ADDRESS: 379 Crescent
- 6. USE: Original: Residential Present: Residential
- 7. ACCESSIBILITY TO PUBLIC: Exterior visible from public road: Yes  No   
Interior accessible: Explain by permission

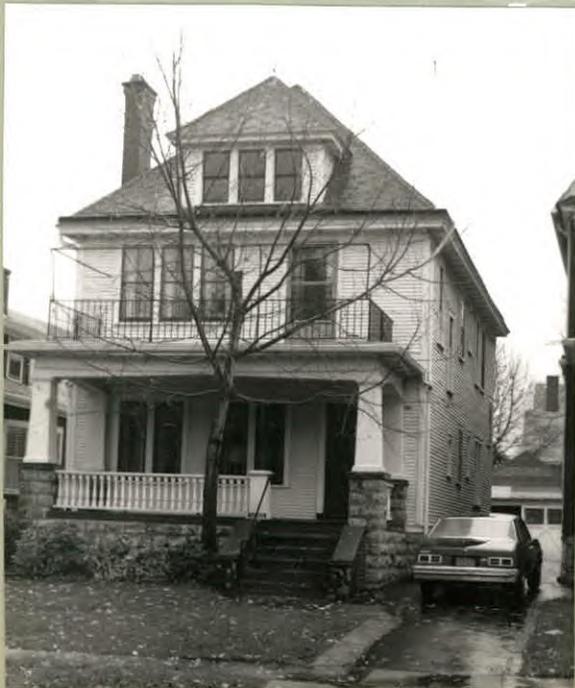
12. PHOTO: 5-14a & 19-8a

Two and a half story American Four Square. Hip roof with modillion blocks under eave. Full-width flat-roof porch has rough cut, regular course stone base. Tapered square supports. Arched curve between porch supports. Spindle balustrade. Glass paneled door. First floor had a set of paired 1/1 windows.

SIGNIFICANCE Second floor lighted porch door. Three part second floor windows, 1/1 lights.

19. DATE OF INITIAL CONSTRUCTION: 1912  
ARCHITECT: \_\_\_\_\_ Hip roof dormer has three 1/1 lights.
