BUILDING-STRUCTURE INVENTORY FORM

1. BUILDING NAME(S): _____
2. COUNTY: Erie TOWN/CITY: Buffalo VILLAGE: _____
3. STREET LOCATION: 393 Crescent Ave
4. OWNERSHIP: a. public b. private 354 Busti,
5. PRESENT OWNER: Domenico Ferrilli ADDRESS: Buffalo, NY 14201
6. USE: Original: Residential Present: Residential
7. ACCESSIBILITY TO PUBLIC: Exterior visible from public road: Yes No
 Interior accessible: Explain by permission

19. DATE OF INITIAL CONSTRUCTION: 1917

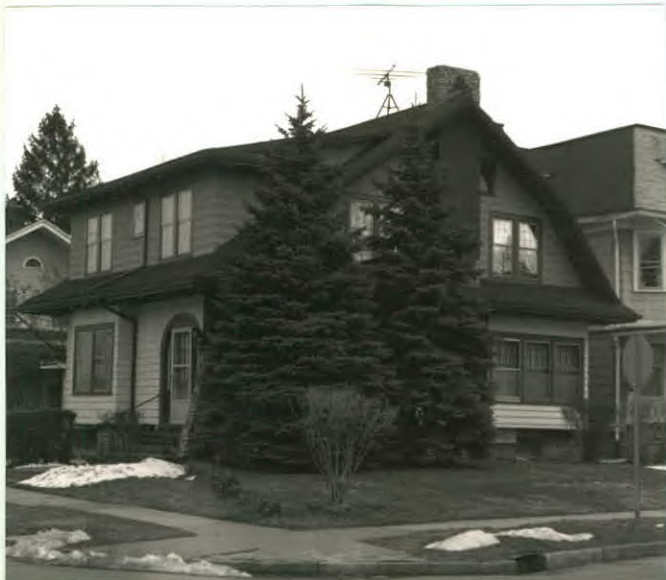
12. PHOTO: 5-18a & 26-3a

Two story with Dutch Colonial Revival style. Side gambrel roof. Brackets under extending eaves. Round arched entrance with lighted door with sidelights. Boxed first floor bay window has pair of 12/1 windows. Full-width shed roof dormer with brackets under eave. Small double hung window flanked by paired 12/1 windows.
