BUILDING-STRUCTURE INVENTORY FORM

- BUILDING NAME(S): \_\_\_\_\_
- COUNTY: Erie TOWN/CITY: Buffalo VILLAGE: \_\_\_\_\_
- STREET LOCATION: 419 Crescent Ave
- OWNERSHIP: a. public  b. private
- PRESENT OWNER: George Hole ADDRESS: 419 Crescent
- USE: Original: Residential Present: Residential
- ACCESSIBILITY TO PUBLIC: Exterior visible from public road: Yes  No   
Interior accessible: Explain by permission

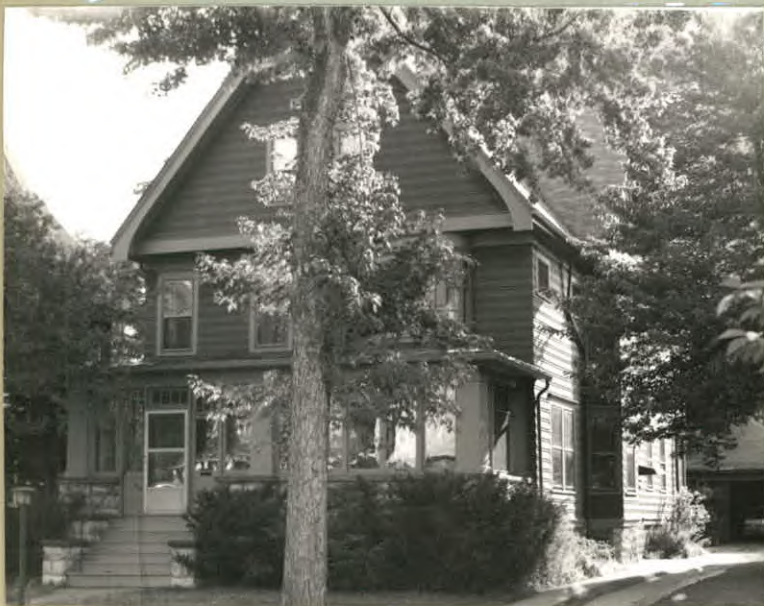
12. PHOTO: 5-20a

Two and a half story with front gacing gable roof. Bargeboard with flared ends. Full-width hip roof porch, enclosed, has tapered square supports. Horizontal bands of single-light windows with three-light transom. Glass paneled door with 4-light transom. Bowed second floor bay has single light with SIGNIFICANCE leaded transom center window with leaded sidelights. 1/1

ARCHITECT: Projecting pedimented gable has three-part window with arched tracery in top light, entablature window head.
