BUILDING-STRUCTURE INVENTORY FORM

1. BUILDING NAME(S): _____
2. COUNTY: Erie TOWN/CITY: Buffalo VILLAGE: _____
3. STREET LOCATION: 425 Woodward Ave
4. OWNERSHIP: a. public b. private
5. PRESENT OWNER: Andrew Debone ADDRESS: 425 Woodward
6. USE: Original: Residential Present: Residential
7. ACCESSIBILITY TO PUBLIC: Exterior visible from public road: Yes No
 Interior accessible: Explain by permission

Dutch Colonial Revival

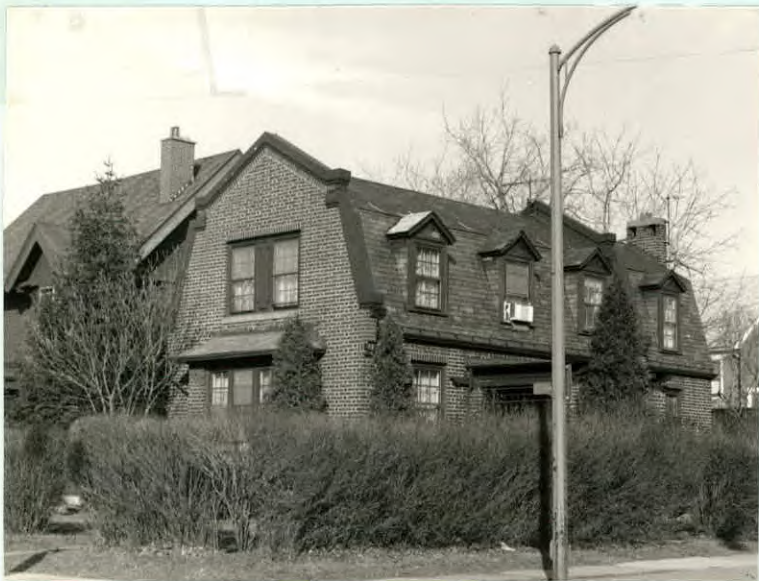
12. PHOTO: 25-8a

18. OTHER NOTABLE FEATURES OF BUILDING AND SITE (including interior features if known):
Two story Dutch Colonial Revival style. Gambrel slate roof with stepped parapet ends. Flemish bond brick pattern. Trellised porch. Wood paneled door. First floor windows 6/6 lights with relieving arch. Gabled dormers, 6/6 light windows. West side has hip roof bay, tri-part window 4/4 lights. Second floor paired 6/6 window with paneled mullion.
