BUILDING-STRUCTURE INVENTORY FORM

- 1. BUILDING NAME(S): \_\_\_\_\_
- 2. COUNTY: Erie TOWN/CITY: Buffalo VILLAGE: \_\_\_\_\_
- 3. STREET LOCATION: 445 Crescent Ave
- 4. OWNERSHIP: a. public  b. private
- 5. PRESENT OWNER: Melvin Alston ADDRESS: 445 Crescent
- 6. USE: Original: Residential Present: Residential
- 7. ACCESSIBILITY TO PUBLIC: Exterior visible from public road: Yes  No   
Interior accessible: Explain by permission

19. DATE OF INITIAL CONSTRUCTION: c. 1910  
 ARCHITECT: \_\_\_\_\_  
 BUILDER: \_\_\_\_\_

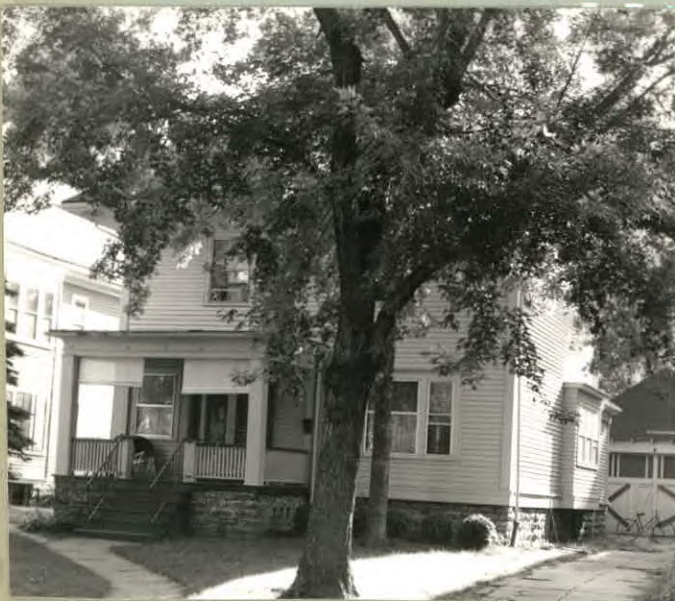
12. PHOTO: 5-26a

18. OTHER NOTABLE FEATURES OF BUILDING AND SITE (including interior features if known):  
 Two and a half story American Four Square with Colonial Revival styling. Hip roof with extending eaves. Partial-width flat roof porch with square supports and stick balustrade. Double door, 10 lights each, with engaged fluted Doric columns supporting entablature. Dentils under cornice. Three-part first floor window, 1/1 lights each. Second floor 1/1 windows. End Doric pilaster strips.
