BUILDING-STRUCTURE INVENTORY FORM

1. BUILDING NAME(S): _____
2. COUNTY: Erie TOWN/CITY: Buffalo VILLAGE: _____
3. STREET LOCATION: 432 Woodward Ave
4. OWNERSHIP: a. public b. private
5. PRESENT OWNER: Mercedes Olsen ADDRESS: 432 Woodward
6. USE: Original: Residential Present: Residential
7. ACCESSIBILITY TO PUBLIC: Exterior visible from public road: Yes No
 Interior accessible: Explain by permission

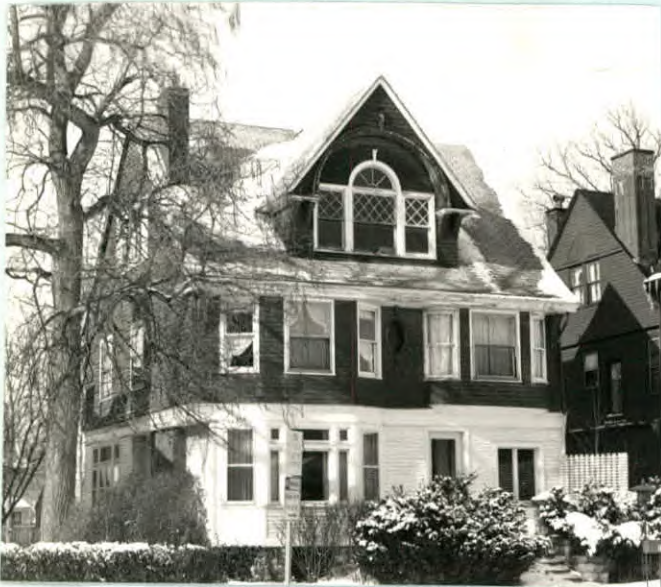
12. PHOTO: 22-24a

Two and a half story Colonial Revival style. Steep pitch side gable roof. First floor glass paneled door with single-light casement window. First floor surmounted by entablature. Two-story semi-hexagonal bay window. First floor has center singlelight with transom and sidelight window, flanking 1/1 light windows.

SIGNIFICANCE Second floor 1/1 windows. Second floor bowed bay has 1/1 window with keystone brackets under roof eave. Steep pitched gable dormer. Cornice end return with paired brackets supporting. Palladian window recessed in round arch with keystone.
