BUILDING-STRUCTURE INVENTORY FORM

* * * * * * * * * * * * * * * * * * * *
ENTIFICATION
BUILDING NAME(S):
COUNTY: Erie TOWN/CITY: BuffaloVILLAGE:
STREET LOCATION: 454 Crescent AVE
OWNERSHIP: a. public b. private
PRESENT OWNER: Wayne Russell ADDRESS: 454 Crescent
USE: Original: Residential Present: Residential
ACCESSIBILITY TO PUBLIC: Exterior visible from public road: Yes 🖾 No 🗆
Interior accessible: Explain by permission
SCRIPTION
BUILDING a. clapboard \(\subseteq \) b. stone \(\subseteq \) c. brick \(\subseteq \) d. board and batten \(\subseteq \)
MATERIAL: e. cobblestone ☐ f. shingles ☒ g. stucco ☐ other: asbestos
STRUCTURAL a. wood frame with interlocking joints
SYSTEM: b. wood frame with light members
(if known) c. masonry load bearing walls

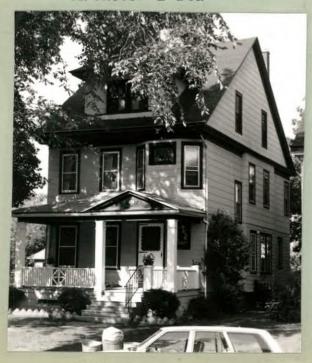
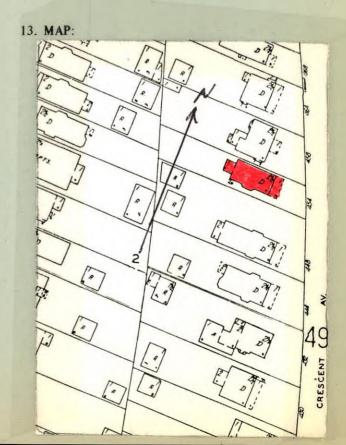
12. PHOTO: 1-24a

18. OTHER NOTABLE FEATURES OF BUILDING AND SITE (including interior features if known):		
Two and a half story house with steep pitch side gable roof.			
	Hip roof full-width porch has pediment over stairs. Square		
	Doric supports with stick balustrade with center diamond shape.		
	Wood and glass paneled door with flanking stained glass rectangular window. 1/1 first and second floor windows. Second floor semi-		
	SIGNIFICANCE hexagonal bay with rectangular center window, prism		
	SIGNIFICANCE TEXASONAL Bay WITH TESTANGULAR STATE OF INITIAL CONSTRUCTION: C. 1895 tracery. Hip roof dormer
