BUILDING-STRUCTURE INVENTORY FORM

- 1. BUILDING NAME(S): _____
- 2. COUNTY: Erie TOWN/CITY: Buffalo VILLAGE: _____
- 3. STREET LOCATION: 444 Woodward Ave
- 4. OWNERSHIP: a. public b. private
- 5. PRESENT OWNER: Leslie Maddox ADDRESS: 444 Woodward
- 6. USE: Original: Residential Present: Residential
- 7. ACCESSIBILITY TO PUBLIC: Exterior visible from public road: Yes No
Interior accessible: Explain by permission

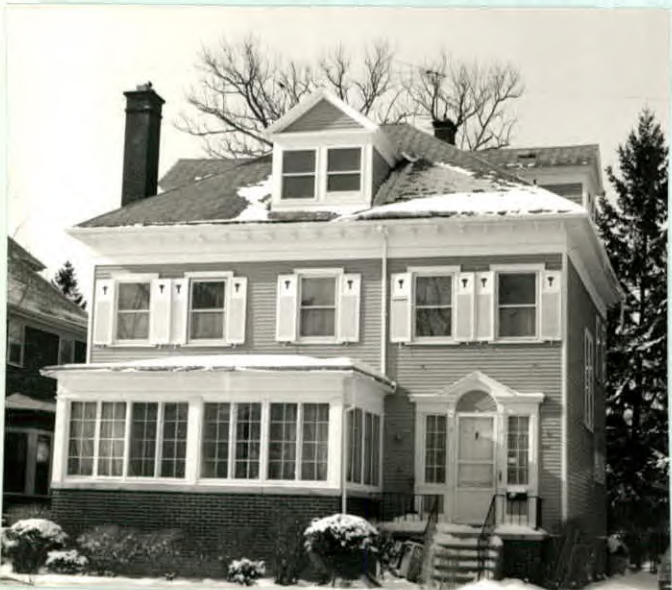
12. PHOTO: 22-27a

Two and a half story with Colonial Revival style influence. Hip roof. Brick first floor partial width wing has four sets of 8 light windows. Pilaster strips flank ends and center. Entablature. Entrance has wood paneled door. Fluted semi-circular blind arch above door. Eight light sidelights. Pedimented entrance

SIGNIFICANCE surround. Pilaster strips support entablature. Second floor has four square-headed

19. DATE OF INITIAL CONSTRUCTION: 1901
 ARCHITECT: _____
 BUILDER: pattern. Entablature with brackets under roof cornice. Gabled dormer has a pair of 1/1 light windows.
