**BUILDING-STRUCTURE INVENTORY FORM**

1. BUILDING NAME(S): \_\_\_\_\_
2. COUNTY: Erie TOWN/CITY: Buffalo VILLAGE: \_\_\_\_\_
3. STREET LOCATION: 593 Crescent Ave
4. OWNERSHIP: a. public  b. private
5. PRESENT OWNER: Anthony Palma ADDRESS: 593 Crescent
6. USE: Original: Residential Present: Residential
7. ACCESSIBILITY TO PUBLIC: Exterior visible from public road: Yes  No   
 Interior accessible: Explain by permission

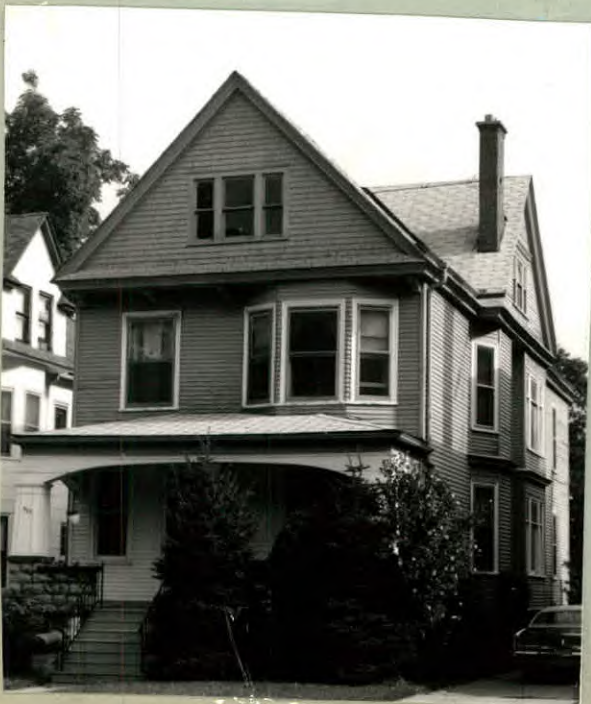
12. PHOTO: 2-14a

Two and a half story frame house with front facing gable roof. Hip roof full-width porch has rough cut, regular course stone base, squat tapered supports with column elaboration. Arched span between supports. Glass paneled door with transom flanked by double hung stained glass windows. First floor window with SIGNIFICANCE multi-light top light. Second floor semi-hexagonal bay. 1/1 windows on second

19. DATE OF INITIAL CONSTRUCTION: c. 1904  
 ARCHITECT: \_\_\_\_\_ floor. Pedimented gable has brackets under base.  
 BUILDER: \_\_\_\_\_ Three-part 1/1 window.
