BUILDING-STRUCTURE INVENTORY FORM

1. BUILDING NAME(S): _____
2. COUNTY: Erie TOWN/CITY: Buffalo VILLAGE: _____
3. STREET LOCATION: 615 Crescent Ave
4. OWNERSHIP: a. public ☐ b. private ☒
5. PRESENT OWNER: Gail Martin ADDRESS: 615 Crescent
6. USE: Original: Residential Present: Residential
7. ACCESSIBILITY TO PUBLIC: Exterior visible from public road: Yes ☒ No ☐
Interior accessible: Explain by permission

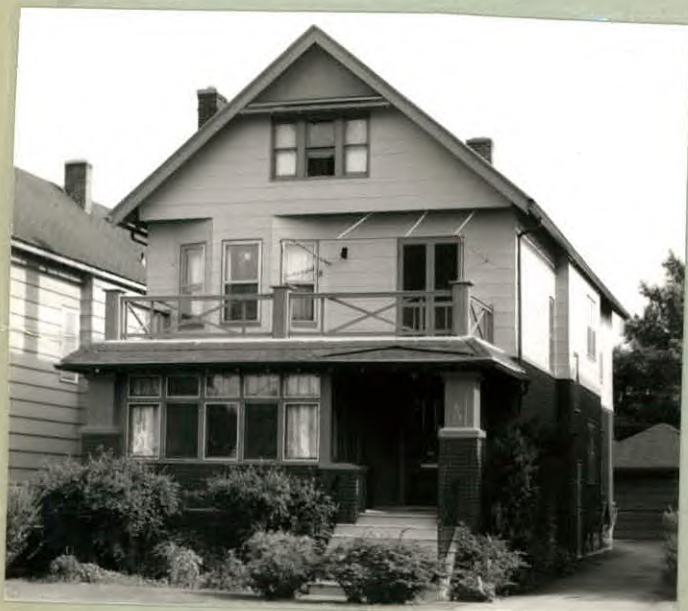
12. PHOTO: 2-8a

18. OTHER NOTABLE FEATURES OF BUILDING AND SITE (including interior features if known):
Two and a half story frame house with front facing gable roof. Full-width deck roof porch partially enclosed has brick base and end piers topped with square supports. Horizontal band of windows, single light with 3-light transom. Recessed entrance has three vertical light beveled glass door with leaded sidelights. SIGNIFICANCE Second floor semi-hexagonal bay with 1/1 windows.

19. DATE OF INITIAL CONSTRUCTION: 1919 Double sash porch door with
center panel decorated with
ARCHITECT: diamond tracery. Pedimented
gable, projecting, has three-part 1/1 window.
BUILDER: Cornice window head.

20. HISTORICAL AND ARCHITECTURAL IMPORTANCE: A gabled frame with Prairie School style porch. Crescent Avenue is the longest curvilinear street in the Parkside subdivision, stretching from Humboldt Avenue to Colvin Street. This street appears on Olmsted's early 1870's maps of "The Parkside." By the 1880's plans for Crescent Avenue had been modified by Olmsted to its current form. Portions of the street were deeded to the city by five different owners over a span of five years, beginning in 1887 near Humboldt and ending in 1892 near Colvin. Crescent Avenue begins and ends within the Parkside subdivision, following Olmsted's rule that a suburban neighborhood street "not lead with special directness toward the town."
