BUILDING-STRUCTURE INVENTORY FORM

- 1. BUILDING NAME(S): \_\_\_\_\_
- 2. COUNTY: Erie TOWN/CITY: Buffalo VILLAGE: \_\_\_\_\_
- 3. STREET LOCATION: 631 Crescent Ave
- 4. OWNERSHIP: a. public  b. private  270 Georgia
- 5. PRESENT OWNER: Paul Battaglia ADDRESS: Buffalo, NY 14201
- 6. USE: Original: Residential Present: Residential
- 7. ACCESSIBILITY TO PUBLIC: Exterior visible from public road: Yes  No   
Interior accessible: Explain by permission

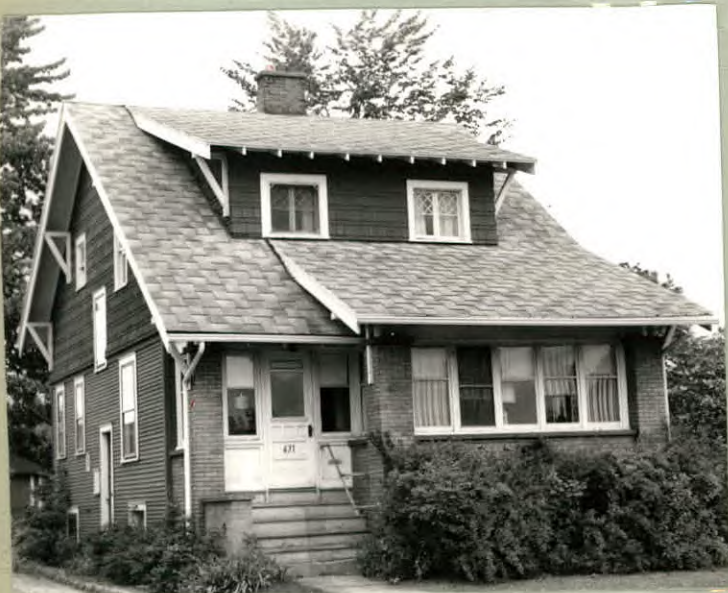
12. PHOTO: 2-19a

18. OTHER NOTABLE FEATURES OF BUILDING AND SITE (including interior features if known):  
Two story bungalow style. Side gable roof. Gable eave extends to front for roof of first floor wing and entrance. Triangular knee braces. Brick wing has end piers. Horizontal band of 1/1 windows. Entrance has glass and wood paneled door. 1/1 sidelights. Shed roof dormer has exposed rafter tails and triangular knee braces. Paired casement windows with diamond shape SIGNIFICANCE tracery in top light.
19. DATE OF INITIAL CONSTRUCTION: 1916
