BUILDING-STRUCTURE INVENTORY FORM

- BUILDING NAME(S): _____
- COUNTY: Erie TOWN/CITY: Buffalo VILLAGE: _____
- STREET LOCATION: 647 Crescent Ave
- OWNERSHIP: a. public b. private
- PRESENT OWNER: Kurt Thalwitzer ADDRESS: 647 Crescent
- USE: Original: Residential Present: Residential
- ACCESSIBILITY TO PUBLIC: Exterior visible from public road: Yes No
Interior accessible: Explain by permission

Dutch Colonial Revival

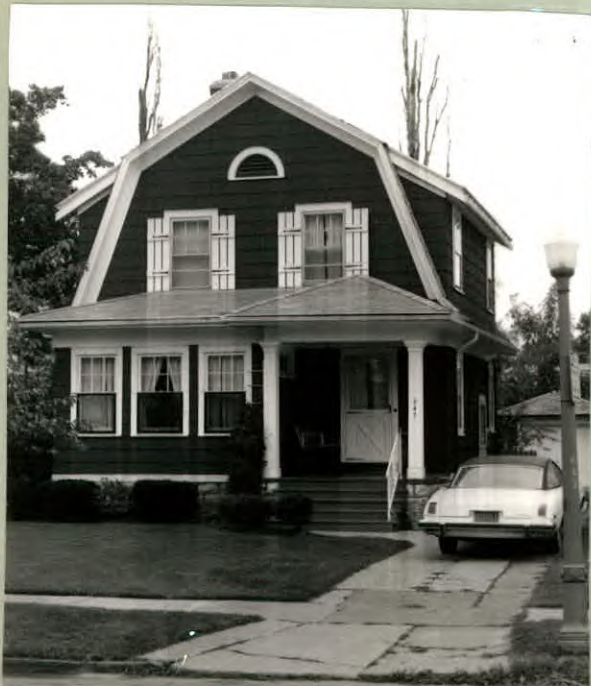
12. PHOTO: 7-1a

18. OTHER NOTABLE FEATURES OF BUILDING AND SITE (including interior features if known):
 Two story Dutch Colonial Revival style. Front facing gambrel roof, with projecting eaves. Hip roof first floor wing has three 6/1 light windows. Continuous entablature. Extends to hip roof projecting porch. Square doric supports. Wood paneled door. Second floor 6/1 light windows. Window shutters. Semi-circular louvred window in gable. Shed roof dormers.
