**BUILDING-STRUCTURE INVENTORY FORM**

YOUR NAME: BUFFALO FRIENDS OF OLMSTED PARKS DATE: February 3, 1984  
 P. O. BOX 590

1. BUILDING NAME(S): \_\_\_\_\_
2. COUNTY: Erie TOWN/CITY: Buffalo VILLAGE: \_\_\_\_\_
3. STREET LOCATION: 659 Crescent Ave
4. OWNERSHIP: a. public  b. private
5. PRESENT OWNER: Catherine Detmers ADDRESS: 659 Crescent
6. USE: Original: Residential Present: Residential
7. ACCESSIBILITY TO PUBLIC: Exterior visible from public road: Yes  No   
 Interior accessible: Explain by permission

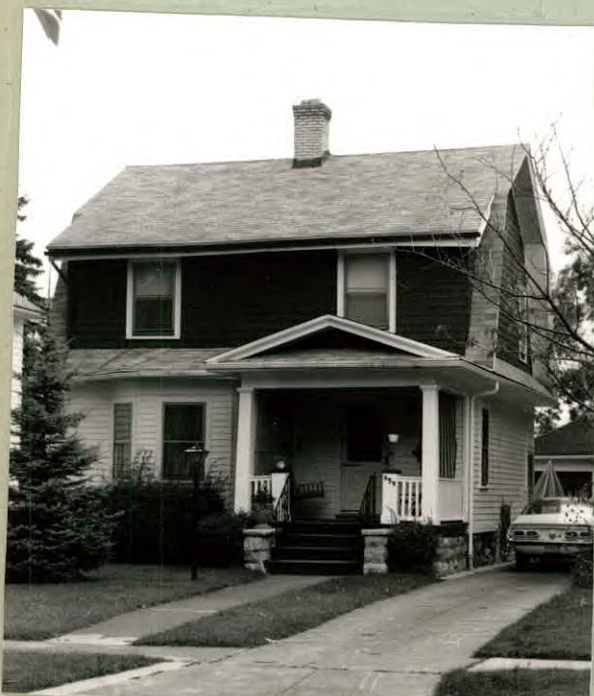
12. PHOTO: 7-4a

18. OTHER NOTABLE FEATURES OF BUILDING AND SITE (including interior features if known):  
 Two story Dutch Colonial Revival style. Side gambrel roof with projecting eaves. Over-scale shed roof dormer. Two 1/1 light square-headed windows. Pedimented entrance porch has square doric supports, stick balustrade, entablature. Wood paneled door. Semi-hexagonal first floor bay has 1/1 light windows.
