**BUILDING-STRUCTURE INVENTORY FORM**

1. BUILDING NAME(S): \_\_\_\_\_
2. COUNTY: Erie TOWN/CITY: Buffalo VILLAGE: \_\_\_\_\_
3. STREET LOCATION: 663 Crescent Ave
4. OWNERSHIP: a. public  b. private
5. PRESENT OWNER: Frank Zuppa ADDRESS: 663 Crescent
6. USE: Original: Residential Present: Residential
7. ACCESSIBILITY TO PUBLIC: Exterior visible from public road: Yes  No   
 Interior accessible: Explain by permission

19. DATE OF INITIAL CONSTRUCTION: 1922

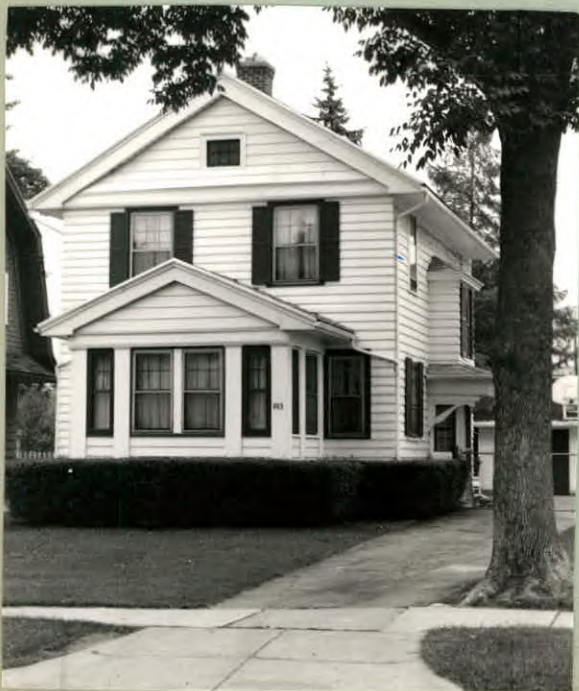
12. PHOTO: 7-5a

Two and a half story residence. Front facing gable roof with bargeboard, flared ends and extending eaves. Partial-width gabled wing has a pair of 6/1 windows and 4/1 sidelights flanked by doric pilaster strips. Second floor 6/1 windows. Window shutters. Gable has small 6-light window. East side has hip roof entrance hood supported by curved brackets with

**SIGNIFICANCE** pendant ends. Hip roof boxed bay above entrance.
