BUILDING-STRUCTURE INVENTORY FORM

DIVISION FOR HISTORIC PRESERVATION NEW YORK STATE PARKS AND RECREATION ALBANY, NEW YORK (518) 474-0479

* * * * * * * * * * * * * * * * * * * *	*
IDENTIFICATION	
1. BUILDING NAME (S):	
1. BUILDING NAME(S):	
3. STREET LOCATION: 667 Crescent Ave	
4. OWNERSHIP: a. public □ b. private ☒

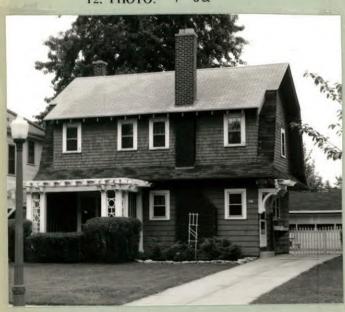
12. РНОТО: 7-6а

e. other	
0. CONDITION: a. excellent □ b. good ☒ c. fair □ d. deteriorated □	
1. INTEGRITY: a. original site 🗵 b. moved 🗆 if so, when?	
c. list major alterations and dates (if known):

18. OTHER NOTABLE FEATURES OF BUILDING AND SITE (including interior features if known): Two story Dutch Colonial Revival style. Side gambrel roof with flared ends and projecting eaves. Shed roof dormer, over-scale, has exposed rafter tails under eave. Exterior brick chimney interrupts dormer. 6/6 square-headed windows with surrounds. First floor 6/6 windows. Partial-width trellised porch has SIGNIFICANCE slender, square doric supports with ornamental trellis

19. DATE OF INITIAL CONSTRUCTION: 1922 work. 12-light double sash door. Trellised entrance
ARCHITECT: hood on east side supported by brackets.
BUILDER:
20. HISTORICAL AND ARCHITECTURAL IMPORTANCE: Typical vernacular adaptation of Dutch Colonial Revival style. Similar to 711 Crescent in building design. Crescent Avenue is the longest curvilinear street in the Parkside subdivision, stretching from Humboldt Avenue to Colvin Street. This street appears on Olmsted's early 1870's maps of "The Parkside." By the 1880's plans for Crescent Avenue had been modified by Olmsted to its current form. Portions of the street were deeded to the city by five different owners over a span of five years, beginning in 1887 near Humboldt and ending in 1892 near Colvin. Crescent Avenue begins and ends within the Parkside subdivision, following Olmsted's rule that a suburban neighborhood street "not lead"
