**BUILDING-STRUCTURE INVENTORY FORM**

1. BUILDING NAME(S): \_\_\_\_\_
2. COUNTY: Erie TOWN/CITY: Buffalo VILLAGE: \_\_\_\_\_
3. STREET LOCATION: 719 Crescent Ave
4. OWNERSHIP: a. public  b. private
5. PRESENT OWNER: Frank Green ADDRESS: 719 Crescent
6. USE: Original: Residential Present: Residential
7. ACCESSIBILITY TO PUBLIC: Exterior visible from public road: Yes  No   
 Interior accessible: Explain by permission

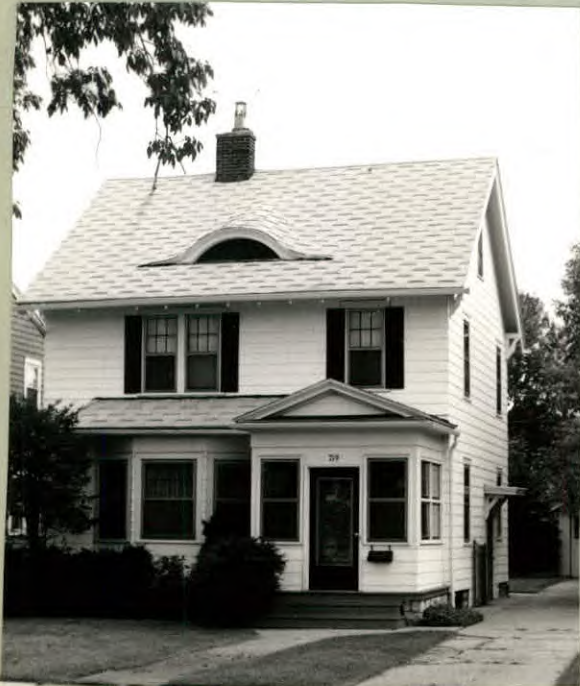
12. PHOTO: 7-19a

18. OTHER NOTABLE FEATURES OF BUILDING AND SITE (including interior features if known):  
 Two story residential structure with side gable roof. Exposed roof rafters on eave. Triangular knee braces at gable ends. Eyebrow window dormer. Pedimented gable entrance porch, enclosed. Glass paneled louvre door flanked by 1/1 windows. Shed roof semi-hexagonal bay on first floor, 8/1 center window with 6/1 side windows. Second floor has a paired and single 6/1 window with window shutters.
