BUILDING-STRUCTURE INVENTORY FORM

YOUR NAME: BUFFALO FRIENDS OF OLMSTED PARKS DATE: February 3, 1984
 P. O. BOX 590

1. BUILDING NAME(S): _____
2. COUNTY: Erie TOWN/CITY: Buffalo VILLAGE: _____
3. STREET LOCATION: 723 Crescent Ave
4. OWNERSHIP: a. public b. private
5. PRESENT OWNER: Francis Doherty ADDRESS: 723 Crescent
6. USE: Original: Residential Present: Residential
7. ACCESSIBILITY TO PUBLIC: Exterior visible from public road: Yes No
 Interior accessible: Explain by permission

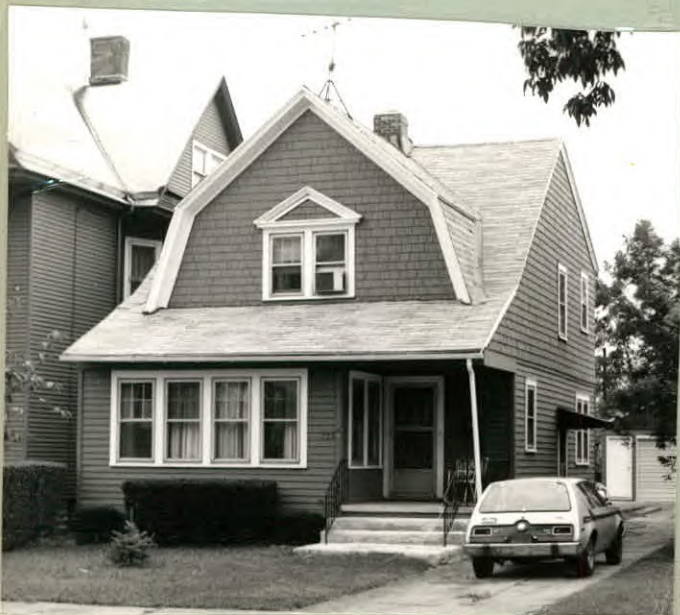
12. PHOTO: 7-20a

18. OTHER NOTABLE FEATURES OF BUILDING AND SITE (including interior features if known):
 Two story Dutch Colonial Revival style. Side gable roof with front extending roof to form porch. Recessed entrance has 6-light wood paneled door. First floor horizontal band of 6/1 windows. Over-scale gambrel roof dormer has pair of 6/1 windows with pediment window head.
