**BUILDING-STRUCTURE INVENTORY FORM**

1. BUILDING NAME(S): \_\_\_\_\_
2. COUNTY: Erie TOWN/CITY: Buffalo VILLAGE: \_\_\_\_\_
3. STREET LOCATION: 756 Crescent Ave
4. OWNERSHIP: a. public  b. private
5. PRESENT OWNER: Richard Cordts ADDRESS: 756 Crescent
6. USE: Original: Residential Present: Residential
7. ACCESSIBILITY TO PUBLIC: Exterior visible from public road: Yes  No   
 Interior accessible: Explain by permission

Dutch Colonial Revival

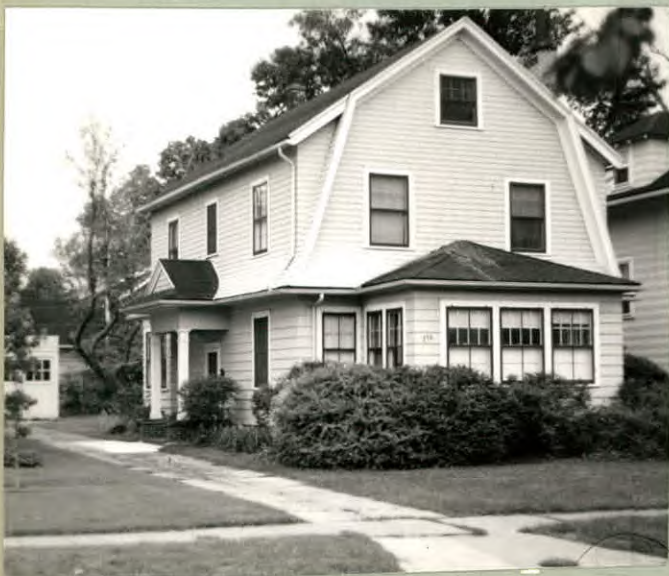
12. PHOTO: 4-1a

18. OTHER NOTABLE FEATURES OF BUILDING AND SITE (including interior features if known):  
Two story Dutch Colonial Revival style. Front facing gambrel roof with flared ends and projecting eave. Hip roof first floor wing has 8/4 light windows. Second floor and gable has 6/6 light windows. East side has entrance porch. Hip roof with false gable, square doric supports, entablature. Over-scale SIGNIFICANCE shed roof dormers on east and west side.
