BUILDING-STRUCTURE INVENTORY FORM

DIVISION FOR HISTORIC PRESERVATION
 NEW YORK STATE PARKS AND RECREATION
 ALBANY, NEW YORK (518) 474-0479

1. BUILDING NAME(S): _____
2. COUNTY: Erie TOWN/CITY: Buffalo VILLAGE: _____
3. STREET LOCATION: 766 Crescent Ave
4. OWNERSHIP: a. public b. private
5. PRESENT OWNER: William Fitzhenry ADDRESS: 766 Crescent
6. USE: Original: Residential Present: Residential
7. ACCESSIBILITY TO PUBLIC: Exterior visible from public road: Yes No
 Interior accessible: Explain by permission

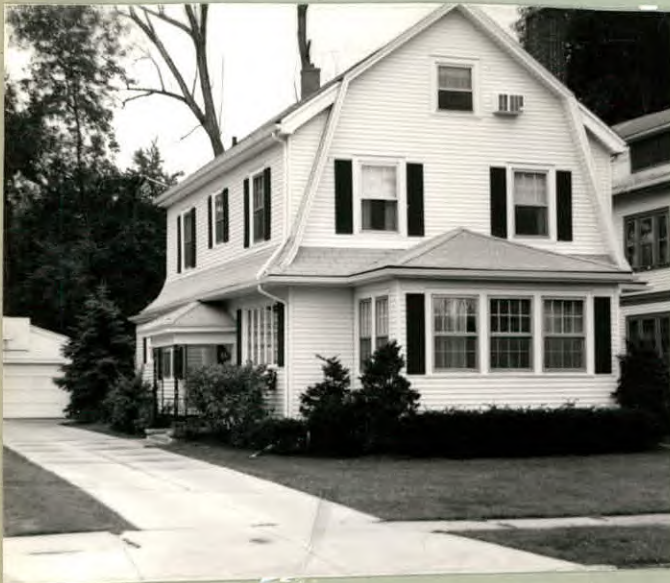
12. PHOTO: 4-3a

8. BUILDING MATERIAL: a. clapboard b. stone c. brick d. board and batten
 e. cobblestone f. shingles g. stucco other: vinyl siding
9. STRUCTURAL SYSTEM: a. wood frame with interlocking joints
 (if known) b. wood frame with light members
 c. masonry load bearing walls
 d. metal (explain) _____
 e. other _____
10. CONDITION: a. excellent b. good c. fair d. deteriorated
11. INTEGRITY: a. original site b. moved if so, when? _____
 c. list major alterations and dates (if known):
Porch supports altered

18. OTHER NOTABLE FEATURES OF BUILDING AND SITE (including interior features if known):
Two story Dutch Colonial Revival style. Front facing gambrel roof. Flared ends and projecting eave. Hip roof first floor wing has three 8/8 light windows with end shutters. Second floor and gable has 6/1 light windows with shutters. Hip roof entrance porch on east side. Shed roof dormer on east and west side.
