**BUILDING-STRUCTURE INVENTORY FORM**

DIVISION FOR HISTORIC PRESERVATION  
NEW YORK STATE PARKS AND RECREATION  
ALBANY, NEW YORK (518) 474-0479

- 1. BUILDING NAME(S): \_\_\_\_\_
- 2. COUNTY: Erie TOWN/CITY: Buffalo VILLAGE: \_\_\_\_\_
- 3. STREET LOCATION: 789 Crescent Ave
- 4. OWNERSHIP: a. public  b. private
- 5. PRESENT OWNER: Rose Baudo ADDRESS: 789 Crescent
- 6. USE: Original: Residential Present: Residential
- 7. ACCESSIBILITY TO PUBLIC: Exterior visible from public road: Yes  No   
Interior accessible: Explain by permission

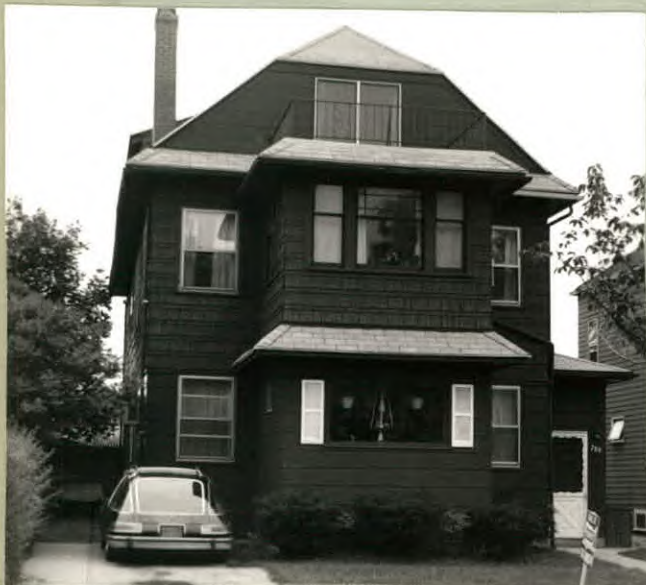
12. PHOTO: 4-7a

Two and a half story residence. Front facing clipped gable roof. Partial-width two story wing. Deck roofs. First floor rectangular single light picture window. Window shutters. Second floor tri-part 1/1 windows. First and second floor 1/1 windows. Gable has a pair of large single light casement windows. East and west side have shed roof dormers.
