A Lifetime of Stress: Analysis and Treatment of an Inlaid Chinese Box

CNS 695 Master's Project

Katherine McFarlin

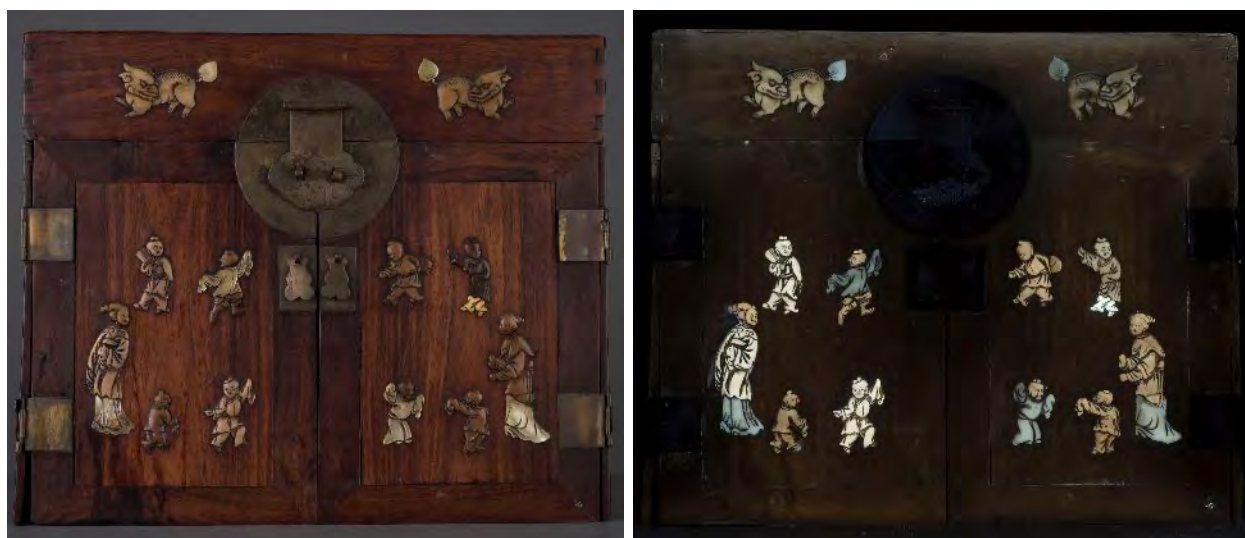
UV fluorescence response can be particularly useful for identifying materials such as ivory and shell, which fluoresce bright white and blue respectively (fig. 3). In some cases, differences in fluorescence were the only way to distinguish inlays that appeared nearly identical in normal illumination. This differential fluorescence can suggest different ratios of components within two iterations of heterogeneous compounds, the presence of impurities, or chemical differences such as hydrate and anhydrate forms of certain inorganic materials (Gleason 1960; Warren et al, 1999). For example, both agate and chalcedony belong to the siliceous quartz family of minerals, and at certain scales can appear identical to the naked eye. However when exposed to longwave UV radiation, the two stones can fluoresce yellow and white respectively (Robbins 1983). These visual indicators are not conclusive on their own as fluorescence is still not entirely understood in some minerals; however, initial visual examination and documentation with UV greatly aids in guiding later analysis, and provides quick visual reference to help differentiate visually similar materials.

Fig. 3. Left: Front, before treatment, normal illumination. Right: Front, before treatment, UVA-induced visible fluorescence. Note the vibrant whites, blues, and creams in UVA, particularly the brightness of the boy's pants in the upper right of the right door. While many of the child figures appeared to be carved from different tonal areas of the same material when viewed with the naked eye, they exhibited distinctly separate fluorescent responses in UVA.

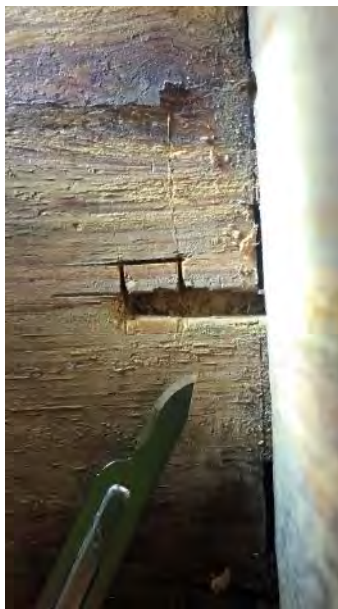
Fig. 12. Interior right back corner of cabinet, showing the sampling location for wood identification, above the lower runner mortise

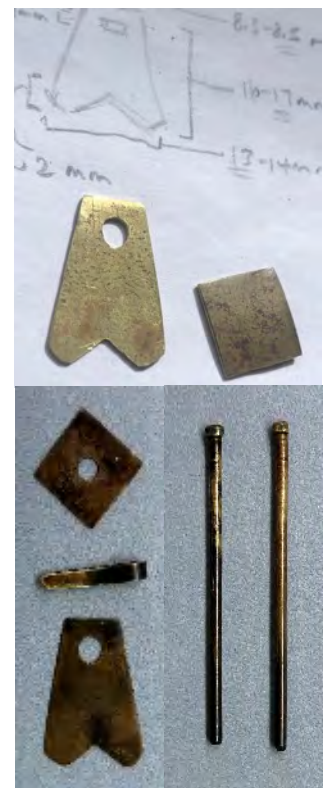
As noted during examination, one of the smaller interior drawers was missing its brass pull tab from the front. No two pulls were identical across the piece, though the small drawers all shared a similar fishtail shape with subtle differences in size and shape. Of the four drawers, the front panel of two had a subtly different tone, and the drawers were split into pairs accordingly. A pattern for the missing pull was made based on the paired drawer, rather than averaging the tabs from all drawers, and new hardware was cut out from 26 gauge brass sheet (fig. 18). Paper mockups were traced onto the brass sheet, and the shapes cut out with a jeweler's saw. All edges were filed and sanded, and a 2mm strip of brass was crimped and shaped around a metal rod to create the looped connector. The center holes for the decorative plate and the pull tab were drilled out with a rotary tool fitted with a #52 bit, and the hole expanded with a small round file. While the new tab isn't a perfect match for the paired hardware, it is cohesive with the overall aesthetic of the hardware.

New pins for the hinges were also fabricated from new 14g brass wire. The wire was cut into approximately 5-6" pieces, rolled straight, and then beaded at one end with a jeweler's torch. The bead was then hammered into a rivet on a draw plate, and the rivet shaped on a belt sander so that it was proportional. Four pins were selected for their superior shaping, checked for fit, and cut to size for each individual hinge.

All hardware was finished with a Sculpt Nouveau Deep Brown Traditional Patina, to match the tone and aging of the existing hardware. The pull tab was threaded between the prongs so that it dangled inside the loop at the end, then the decorative plate threaded over both prongs to lock the tab in place. The prongs were then threaded through the hole in the front of the drawer and bent back in opposite direction to secure the new tab hardware in place. Once in place, the new tab blended with the surrounding hardware. The back of the pull-tab was inscribed with the author's initials to label it as a replacement piece.

Fig. 18. Top: New brass pull-tab and decorative plate during fabrication, next to preparatory drawings and measurements. Bottom: Finished brass hardware.
