**BUILDING-STRUCTURE INVENTORY FORM**

- BUILDING NAME(S): \_\_\_\_\_
- COUNTY: Erie TOWN/CITY: Buffalo VILLAGE: \_\_\_\_\_
- STREET LOCATION: 6 Elam Pl
- OWNERSHIP: a. public  b. private
- PRESENT OWNER: Richard Gilman ADDRESS: 6 Elam Place
- USE: Original: Residential Present: Residential
- ACCESSIBILITY TO PUBLIC: Exterior visible from public road: Yes  No   
Interior accessible: Explain by permission

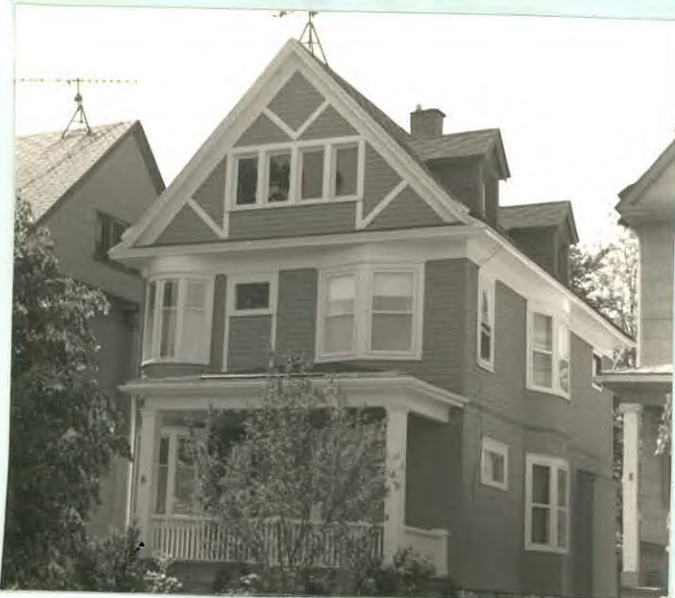
12. PHOTO: 42-20a

18. OTHER NOTABLE FEATURES OF BUILDING AND SITE (including interior features if known):  
Two and a half story frame with front facing gable roof. Partial width hip roof porch. Square end Doric supports. Stick balustrade. Glass paneled door. Right bay first floor has single-hung, single light window. Two story semi-circular bay to left. Three single-hung windows first and second floor with leaded top light. Flanking bay to left on second floor is small rectangular leaded window with extending

19. DATE OF INITIAL CONSTRUCTION: 1904  
vertical strips from frame.  
ARCHITECT: Right side has two-sided bay. Double hung 1/1 windows.  
Shingled second floor and gable. Wide band of trim  
BUILDER: below gable eave. Pedimented gable has stick styling  
in angle shapes. Four single-light casement windows.
