BUILDING-STRUCTURE INVENTORY FORM

DIVISION FOR HISTORIC PRESERVATION NEW YORK STATE PARKS AND RECREATION

| ALBANY, NEW YORK (518) 474-0479 | NEG. NO. |
|--|---|
| 3. STREET LOCATION: 2136 Main St | |

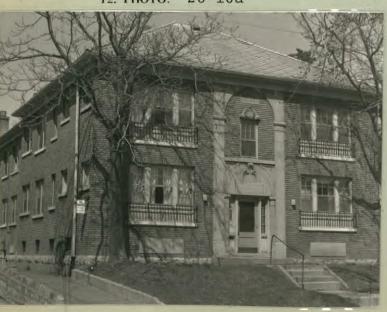
28-16a 12. PHOTO:

| 14. THREATS TO BUILDING: a. none known ☑ b. zoning □ c. roads □ d. developers □ e. deterioration □ f. other: | |
|---|---|
| 18. OTHER NOTABLE FEATURES OF BUILDING AND SITE (including interior features if known): Two story brick with Italian Renaissance styling. Simple hip roof | |
| with boxed overhanging eaves. Flat symmetrical front facade. Center bay has two story blind arcade in stone. Doric pilaster strips. Glass and wood paneled door flanked on one side by 8-light sidelight. Doric pilaster strips flank and support semi-circular | it |
| SIGNIFICANCE 19. DATE OF INITIAL CONSTRUCTION: 1929 enframing medallion. Second floor has double hung 6/1 | ıd |
| ARCHITECT: window. Semi-circular stone arch above decorated with highly carved laurel. Square panel in stone etched with '2136'. First and second floor end bays have three-part windows; 6/1 center, with 4/1 sides. | h |
| 20. HISTORICAL AND ARCHITECTURAL IMPORTANCE: Paneled apron. Wrought irobalcony. Relieving arch. | n |
