BUILDING-STRUCTURE INVENTORY FORM

1. BUILDING NAME(S): _____
2. COUNTY: Erie TOWN/CITY: Buffalo VILLAGE: _____
3. STREET LOCATION: 2142 Main St
4. OWNERSHIP: a. public b. private
5. PRESENT OWNER: James Archibald ADDRESS: 2142 Main Street
6. USE: Original: Residential Present: School
7. ACCESSIBILITY TO PUBLIC: Exterior visible from public road: Yes No
 Interior accessible: Explain by permission

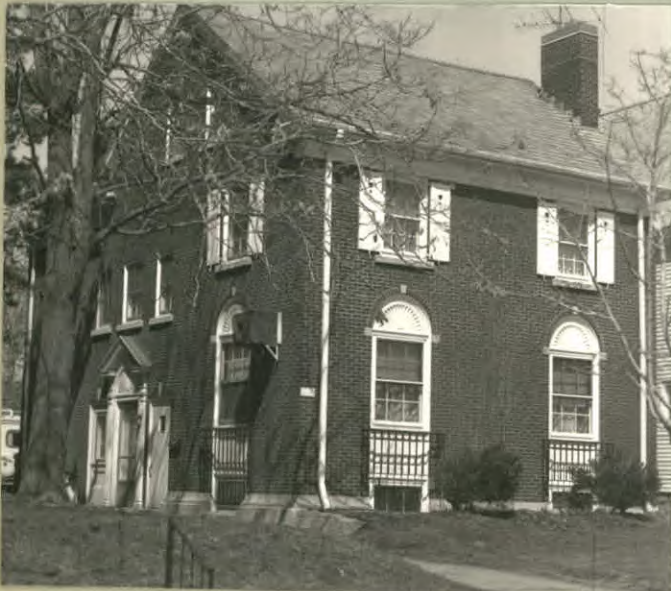
12. PHOTO: 28-17a

Two and a half story Colonial Revival style with Adamesque details. Side gable roof with cornice end returns. Basement level windows; rectangular 3 light with entablature window head. First floor end bays have double hung 6/6 window. Blind semi-circular arch with fan motif decorating. Relieving arch with stone keystone and end stops. Apron with false wrought iron balcony. Second floor has

19. DATE OF INITIAL CONSTRUCTION: 1924 double sash, 6/6 windows. Two

paneled window shutters with
ARCHITECT: heart shape cut-out pattern. Frieze at roof line
decorated with triglyphs and bull's eye motifs. South
BUILDER: side has pedimented entrance. Cornice end return.
Lighted door flanked by pilaster strips. Filled-in

20. HISTORICAL AND ARCHITECTURAL IMPORTANCE: fan light decorated with fan motif. Entrance flanked on one side by 3 light sidelight. Relieving arch with keystone. Wood door has replaced other sidelight.
