BUILDING-STRUCTURE INVENTORY FORM

1. BUILDING NAME(S): _____
2. COUNTY: Erie TOWN/CITY: Buffalo VILLAGE: _____
3. STREET LOCATION: 17 Oakwood
4. OWNERSHIP: a. public b. private
5. PRESENT OWNER: Laurence Brickman ADDRESS: 17 West Oakwood
6. USE: Original: Residential Present: Residential
7. ACCESSIBILITY TO PUBLIC: Exterior visible from public road: Yes No
 Interior accessible: Explain by permission

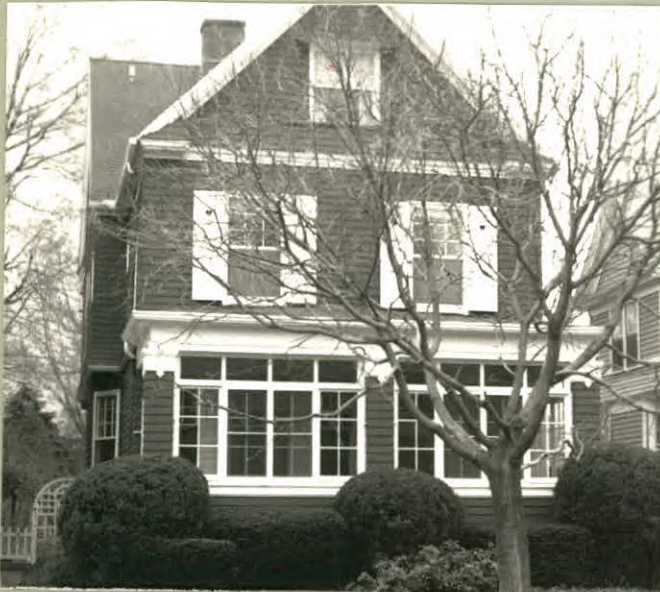
12. PHOTO: 36-1a

Two and a half story with Colonial Revival styling. Front facing gable roof with cornice end returns. Full-width Craftsman style porch, enclosed. Low-pitch hip roof with extending eaves. Shingled base and shingled Doric pilasters. Diamond design decorates pilaster at capital. Two 4-part windows; six lights each with transom. Right side of porch has lighted

19. DATE OF INITIAL CONSTRUCTION: c. 1893
ARCHITECT: lighted sidelights. Second floor has two double-hung 9/1 windows. Two paneled window shutters with heart-shaped cut-out pattern.
BUILDER: Cornice with dentils spans second floor. Gable has recessed window with curved sides. Double hung 15/1
