BUILDING-STRUCTURE INVENTORY FORM

- BUILDING NAME(S): _____
- COUNTY: Erie TOWN/CITY: Buffalo VILLAGE: _____
- STREET LOCATION: 19 Florence Ave
- OWNERSHIP: a. public b. private
- PRESENT OWNER: Lillian Purpura ADDRESS: 19 Florence
- USE: Original: Residential Present: Residential
- ACCESSIBILITY TO PUBLIC: Exterior visible from public road: Yes No
Interior accessible: Explain by permission

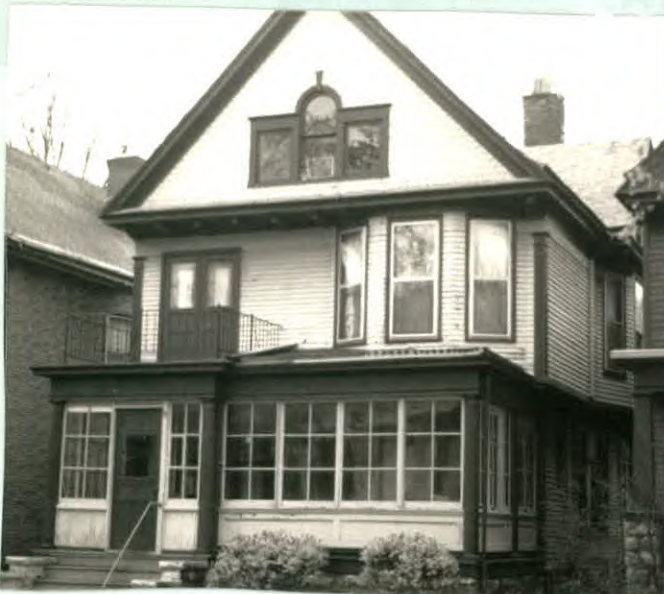
12. PHOTO: 37-26a

Two and a half story frame Colonial Revival style. Front facing gable roof. Full-width flat-roof enclosed porch. Slight projecting entrance bay. One-light wood paneled door flanked by 6 light windows. Bay flanked by fluted semi-engaged doric columns. Four 6 light windows. Paneled apron. End fluted semi-hexagonal column. Entablature with capping cornice.

19. DATE OF INITIAL CONSTRUCTION: 1905 Second floor semi-hexagonal bay. Double hung 1/1 windows.
 ARCHITECT: Left bay has double glass and wood paneled doors.
Plain window and door surround. End fluted doric
 BUILDER: pilasters. Band of trim below gable eave. Modillion
style brackets under eave. Pedimented gable, shingled,

20. HISTORICAL AND ARCHITECTURAL IMPORTANCE: has Palladian window.
