BUILDING-STRUCTURE INVENTORY FORM

1. BUILDING NAME(S): _____
2. COUNTY: Erie TOWN/CITY: Buffalo VILLAGE: _____
3. STREET LOCATION: 26 Jewett Pkwy
4. OWNERSHIP: a. public b. private
5. PRESENT OWNER: Laurence J. Chirico ADDRESS: 26 Jewett Parkway
6. USE: Original: Residential Present: Residential
7. ACCESSIBILITY TO PUBLIC: Exterior visible from public road: Yes No
 Interior accessible: Explain by permission

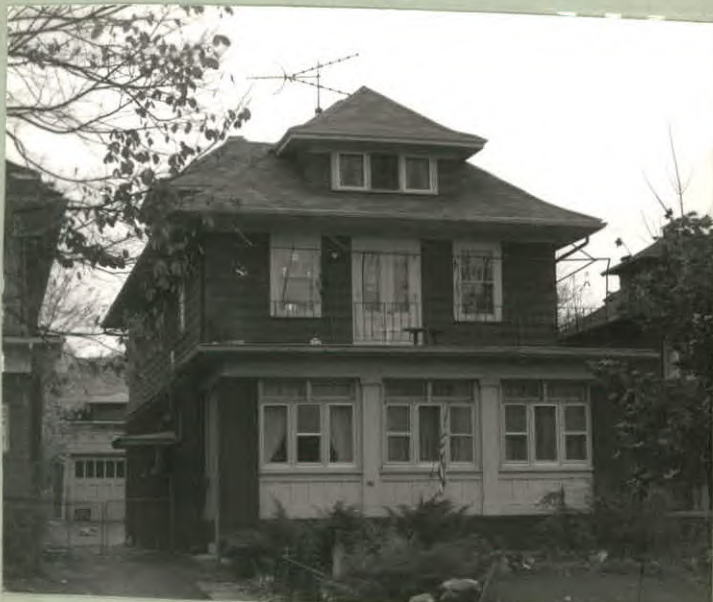
12. PHOTO: 18-6a

Two story American Four Square. Hip roof with flared eaves. Dormers with flared eaves on east and north side of roof have three four light windows each. Enclosed porch across front of house has brick piers and base with multipaned windows and wooden pilasters between piers. Multipaned double door leads out to open porch
SIGNIFICANCE on roof of first floor porch. Entrance with overdoor
