BUILDING-STRUCTURE INVENTORY FORM DIVISION FOR HISTORIC PRESERVATION NEW YORK STATE PARKS AND RECREATION ALBANY, NEW YORK (518) 474-0479	FOR OFFICE USE ONLY UNIQUE SITE Q22-40 5363 QUAD SERIES NEG. NO
YOUR NAME	DATE: June 5, 1984
YOUR ADDRESSUFFALO, NEW YORK 14205 - 0590	
ORGANIZATION (if any):

* * * * * * * * * * * * * * * * * * * *	* * * * * * * * * * * * * * * * *
IDENTIFICATION	
1. BUILDING NAME (S):	and the second
2. COUNTY: <u>Erie</u> TOWN/CITY: 3. STREET LOCATION: <u>2152 Main St</u>	Buffalo VILLAGE:

3. STREET LOCATION:2152 Main St	
4. OWNERSHIP: a. public 🗆 b. private 🖾	
5. PRESENT OWNER: Cleon Service	ADDRESS: 2152 Main Street
6. USE: Original: Residential	Present: <u>Commercial/Residential</u>

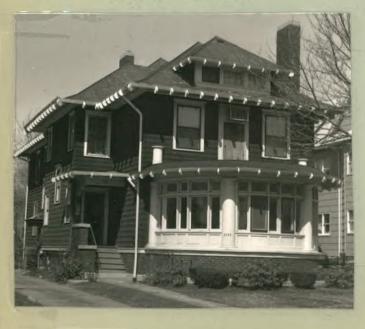
12. PHOTO: 28-19a

18. OTHER NOTABLE FEATURES OF BUILDING AND SITE (including interior features if known): Two and a half story with Craftsman styling. Hip roof with flared extending eaves. Exposed rafter tails with decorative curved ends projecting beyond roof eaves of roof proper, porch and dormer roof. Semi-circular one-story wing has brick base. Engaged Doric columns flank window bays. Each bay has two single light windows significance flanked by sidelight and leaded transoms. Paneled apron. Deck roof. Second floor wood paneled porch door flanked ARCHITECT: by double-hung 6/1 windows. Entablature window and

ARCHITECT: by double-hung 6/1 windows. Entablature window and door surrounds. Hip roof dormer has three rectangular BUILDER: windows; 6 light center and 4 light sides. South side has flat roof entrance hood supported by single curved 20. HISTORICAL AND ARCHITECTURAL IMPORTANCE: brackets. Glass paneled door with horizontal and vertical
