Colvin 0027; Building-Structure Inventory Form

BUILDING-STRUCTURE INVENTORY FORM

- 1. BUILDING NAME(S): _____
- 2. COUNTY: Erie TOWN/CITY: Buffalo VILLAGE: _____
- 3. STREET LOCATION: 27 Colvin Ave
- 4. OWNERSHIP: a. public b. private
- 5. PRESENT OWNER: Bernard H. Nathan ADDRESS: 27 Colvin Avenue, Bflo
- 6. USE: Original: Residence Present: Residence
- 7. ACCESSIBILITY TO PUBLIC: Exterior visible from public road: Yes No
Interior accessible: Explain By Permission

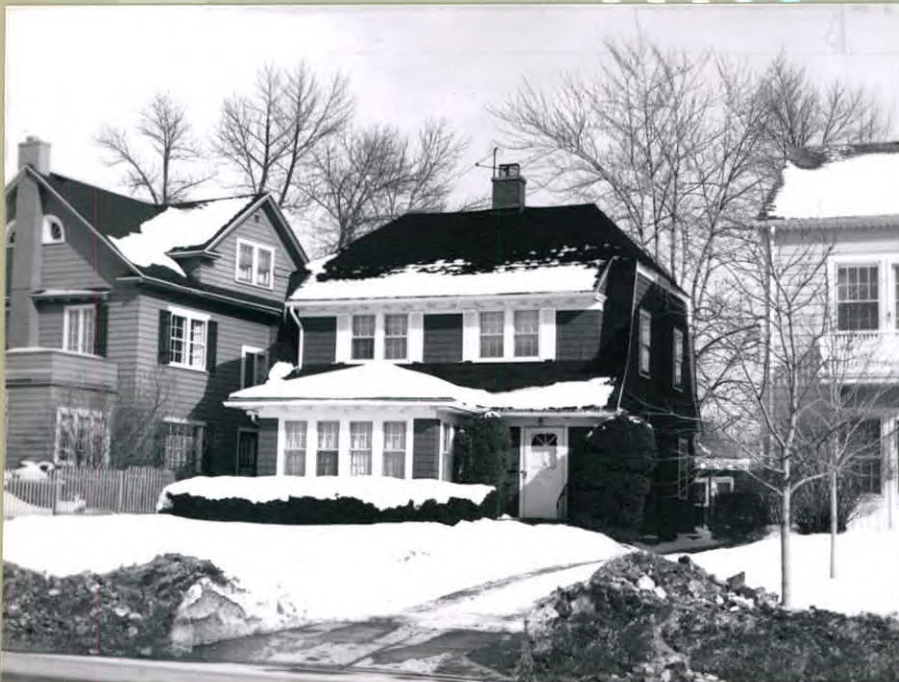
12. PHOTO: 20-4a

18. OTHER NOTABLE FEATURES OF BUILDING AND SITE (including interior features if known):
 Two story Dutch Colonial Revival style. Side gambrel roof with clipped gable ends. Full width shed dormer has brackets under extended eave. A set of paired square-headed 6/6 windows in dormer. Window shutters. Shed roof projecting wing and entrance. Brackets under projecting eave. Wing has a horizontal band of four square-headed 6/6 windows. Entrance has paneled door with semi-circular light.
