BUILDING-STRUCTURE INVENTORY FORM

- BUILDING NAME(S): _____
- COUNTY: Erie TOWN/CITY: Buffalo VILLAGE: _____
- STREET LOCATION: 21 Florence Ave
- OWNERSHIP: a. public b. private
- PRESENT OWNER: Cecilia Gabriel ADDRESS: 21 Florence
- USE: Original: Residential Present: Residential
- ACCESSIBILITY TO PUBLIC: Exterior visible from public road: Yes No
Interior accessible: Explain by permission

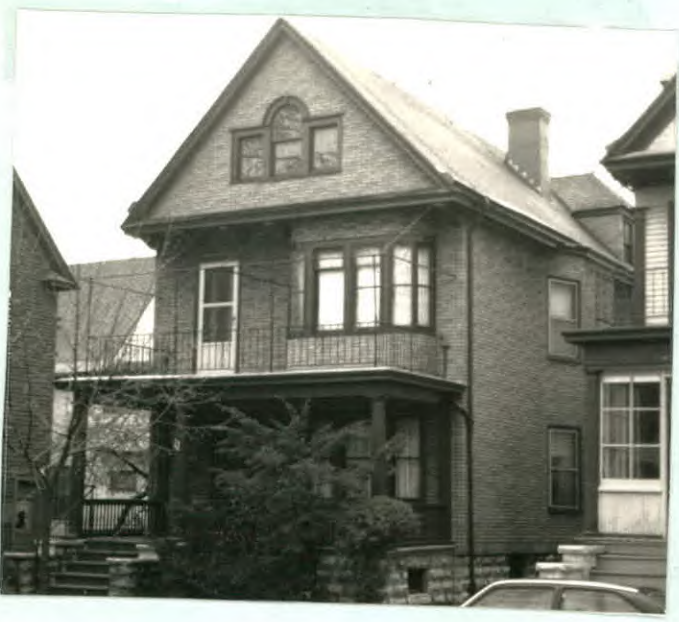
12. PHOTO: 37-27a

Two and a half story frame with Colonial Revival styling. Front facing gable roof. Full-width flat roof porch. Rough cut, regular course stone base. Doric columns support entablature. Spindle balustrade. Glass and wood paneled door flanked on one side by leaded rectangular window. Tri-part first floor window.

SIGNIFICANCE Double hung 1/1 windows. Second floor 3-light glass paneled porch door. Bowed

19. DATE OF INITIAL CONSTRUCTION: c. 1905 bay. Paired single hung
ARCHITECT: windows with leaded top light flanked by paired
leaded sidelights. Scroll-like brackets under
BUILDER: gable eave. Pedimented gable has Palladian window.
