**BUILDING-STRUCTURE INVENTORY FORM**

UNIQUE SITE NO. 029-40-5846 D07  
QUAD \_\_\_\_\_  
SERIES \_\_\_\_\_  
NEG. NO. \_\_\_\_\_

- 1. BUILDING NAME(S): \_\_\_\_\_
- 2. COUNTY: Erie TOWN/CITY: Buffalo VILLAGE: \_\_\_\_\_
- 3. STREET LOCATION: 17 Willow Lawn
- 4. OWNERSHIP: a. public  b. private
- 5. PRESENT OWNER: Henry Strasner ADDRESS: 17 Willow Lawn
- 6. USE: Original: Residential Present: Residential
- 7. ACCESSIBILITY TO PUBLIC: Exterior visible from public road: Yes  No   
Interior accessible: Explain by permission

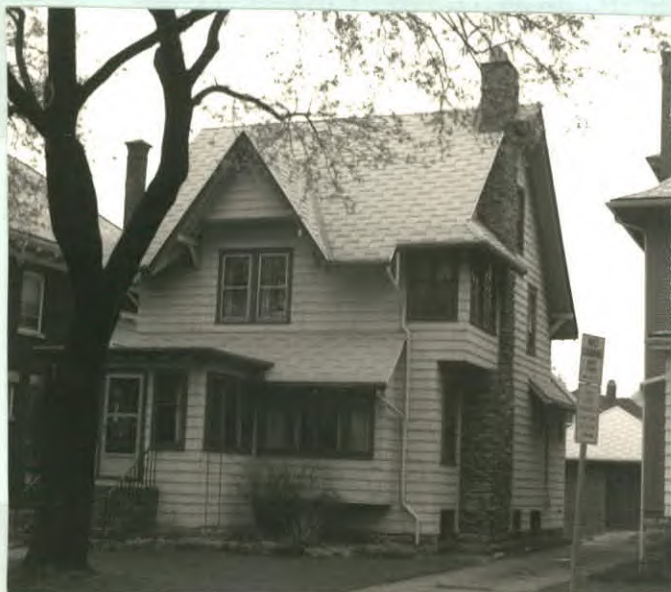
12. PHOTO: 39-28a

Two and a half story shingle residence influenced by Craftsman style. Side gable roof with exposed rafter tails under extending eaves. Partial-width flat roof enclosed porch extends from first floor shed roof bay. Brackets under porch eave. Lighted porch door flanked by double-hung 6/1 windows. First floor boxed bay with shed roof. Four single-hung windows 6/1 light.

SIGNIFICANCE 19. DATE OF INITIAL CONSTRUCTION: 1906 Second floor has paired

double hung windows.

ARCHITECT: Diamond tracery in top light. Gable over second floor extends through the cornice. Knee brace

BUILDER: supports. Right corner bay extends over first floor. Paired casement windows with diamond light

20. HISTORICAL AND ARCHITECTURAL IMPORTANCE: tracery.
