BUILDING-STRUCTURE INVENTORY FORM

1. BUILDING NAME(S): _____
2. COUNTY: Erie TOWN/CITY: Buffalo VILLAGE: _____
3. STREET LOCATION: 18 Summit Ave
4. OWNERSHIP: a. public b. private
5. PRESENT OWNER: Elkin N. Arnold ADDRESS: 18 Summit
6. USE: Original: Residential Present: Residential
7. ACCESSIBILITY TO PUBLIC: Exterior visible from public road: Yes No
 Interior accessible: Explain by permission

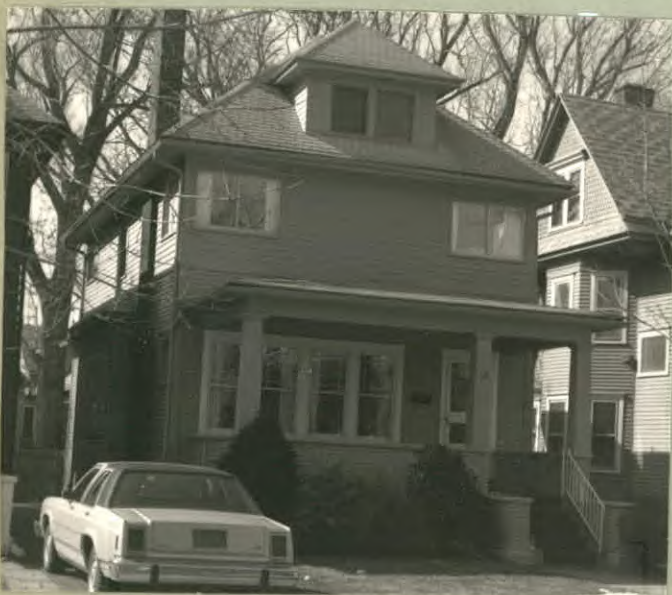
12. PHOTO: 27-3a

18. OTHER NOTABLE FEATURES OF BUILDING AND SITE (including interior features if known):
Two and a half story American Four Square. Hip roof. Full-width hip roof porch has tapered square doric supports. Clapboard first floor. Glass and wood paneled door. Four-part first floor window had horizontal and vertical glass bands in top light. Entablature surround. End pilaster strips on first floor. Second floor shingled. End bays have a pair of single-light windows. Hip roof dormer

19. DATE OF INITIAL CONSTRUCTION: 1914
ARCHITECT: _____ has pair single light windows with horizontal and vertical banding.
BUILDER: _____
