BUILDING-STRUCTURE INVENTORY FORM

- 1. BUILDING NAME(S): _____
- 2. COUNTY: Erie TOWN/CITY: Buffalo VILLAGE: _____
- 3. STREET LOCATION: 1338 Amherst St
- 4. OWNERSHIP: a. public b. private
- 5. PRESENT OWNER: Michael Ball ADDRESS: 1338 Amherst Street
- 6. USE: Original: Residential Present: Residential
- 7. ACCESSIBILITY TO PUBLIC: Exterior visible from public road: Yes No
Interior accessible: Explain by permission

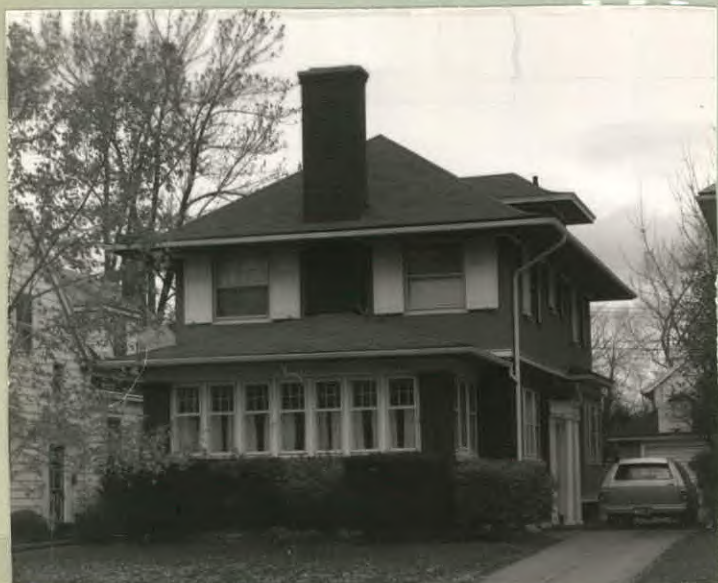
12. PHOTO: 11-35a

Two story American Four Square. Hip roof with flared eaves. Hipped dormer with flared eaves on the east facade. Exterior chimney on front of house. Enclosed porch across front of house has a hip roof and 13 six light over single pane windows. Entrance on east side of house has **SIGNIFICANCE** two doric columns and a curved overdoor. Second floor is

19. DATE OF INITIAL CONSTRUCTION: stuccoed. First floor is brick.
C.1915
