**BUILDING-STRUCTURE INVENTORY FORM**

1. BUILDING NAME(S): \_\_\_\_\_
2. COUNTY: Erie TOWN/CITY: Buffalo VILLAGE: \_\_\_\_\_
3. STREET LOCATION: 59 Parkside Ave
4. OWNERSHIP: a. public  b. private
5. PRESENT OWNER: David C. Zimmerman ADDRESS: 59 Parkside Avenue
6. USE: Original: Residential Present: Residential
7. ACCESSIBILITY TO PUBLIC: Exterior visible from public road: Yes  No   
 Interior accessible: Explain by permission

19. DATE OF INITIAL CONSTRUCTION: c. 1915

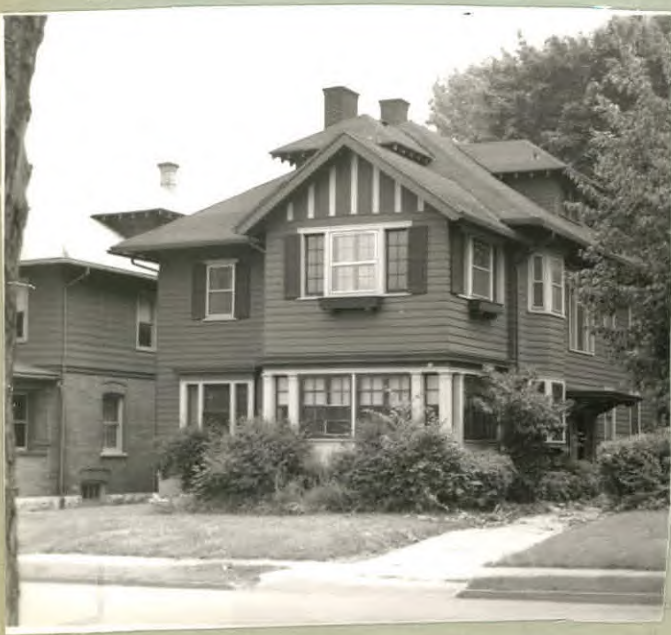
12. PHOTO: 12 8a

18. OTHER NOTABLE FEATURES OF BUILDING AND SITE (including interior features if known):  
Two story modified American Four Square. Hip roof and hipped dormers with wide overhanging eaves. A two story gabled section projects from the front facade and has stick detailing in the gable. The first story of this section has a sunporch with pilasters with classical detailing. A tripartite window with leaded panes is located at the northern corner of the west facade. The entrance is

18. located on the south facade. A large tripartite window is above the entranceway. A two story bay projects from the south facade to the west of the entrance. The east facade has an open porch on the second story.
20. Unique example of the American Four Square house that was built in the Parkside neighborhood. This house is located on Parkside Avenue, a street conceived by FLO around 1873 as part of a residential "suburb" adjacent to Delaware Park. This suburb was called "The Parkside" by Olmsted and appears on an 1876 map drawn by him as a proposed area of curved winding streets on the north and east sides of the park. Parkside Avenue was actually created
