BUILDING-STRUCTURE INVENTORY FORM

- 1. BUILDING NAME(S): _____
- 2. COUNTY: Erie TOWN/CITY: Buffalo VILLAGE: _____
- 3. STREET LOCATION: 1342 Amherst St.
- 4. OWNERSHIP: a. public b. private
- 5. PRESENT OWNER: Richard Walsh ADDRESS: 1342 Amherst St.
- 6. USE: Original: Residentail Present: Residential
- 7. ACCESSIBILITY TO PUBLIC: Exterior visible from public road: Yes No
Interior accessible: Explain by permission

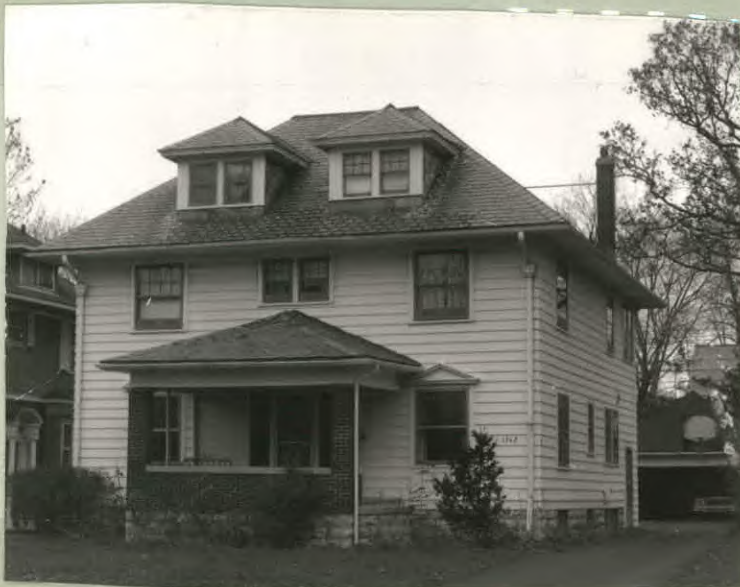
12. PHOTO: 11-36a

Two story American Four Square. Hip roof with two hipped dormers on the front facade. Both dormers have two six light over single pane windows. Porch over entrance has a hip roof, brick piers and a brick balustrade. Entrance has sidelights and a multipaned door. Stone foundation.
