FOR OFFICE USE ONLY
BUILDING-STRUCTURE INVENTORY F	
DIVISION FOR HISTORIC PRESERVATION	UNIQUE SITE NO. 5620
NEW YORK STATE PARKS AND RECREATION	QUAD
ALBANY, NEW YORK (518) 474-0479	SERIES
ALDAN1, NEW TORK (518) 474-0479	NEG. NO
YOUR NAME: Debra A. Mattice	DATE: August 7, 1984
37 Congress, Bf	10 14213 TELEPHONE: (716) 884-5899
	of Buffalo - Division of Planning
OKOANIZATION (II aliy).	of salidity styleton of fluming

3. STREET LOCATION: 32 Till	linghast Pl
4. OWNERSHIP: a public b priva	ate A
5. PRESENT OWNER: Pliny H. Hayes II	ADDRESS: 32 Tillinghast Place, Bflo
6. USE: Original:Residence	Present: Residence

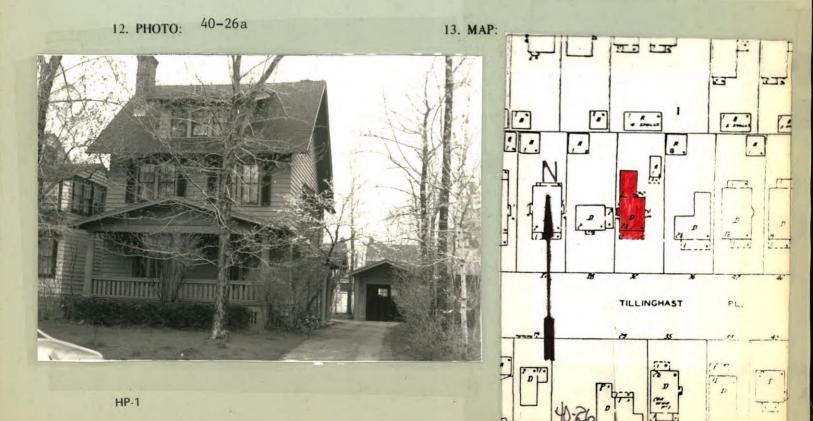
Two and one half story American Four Square. Steep pitched side gable roof. Gabled full-length porch has Doric column supports, stick balustrade. Double sash doors lead to porch, two sets. Second floor has a set of paired square-headed 6/1 windows. Window shutters. Shed roof dormer has three windows 6/1 light. East side has shed roof oriel. Pedimented gable entrance hood on east side SIGNEPCANCE by Doric columns.
