BUILDING-STRUCTURE INVENTORY FORM

- BUILDING NAME(S): _____
- COUNTY: Erie TOWN/CITY: Buffalo VILLAGE: _____
- STREET LOCATION: 60 Florence Ave
- OWNERSHIP: a. public b. private
- PRESENT OWNER: George Freiberg ADDRESS: 60 Florence
- USE: Original: Residential Present: Residential
- ACCESSIBILITY TO PUBLIC: Exterior visible from public road: Yes No
Interior accessible: Explain by permission

19. DATE OF INITIAL CONSTRUCTION: 1909

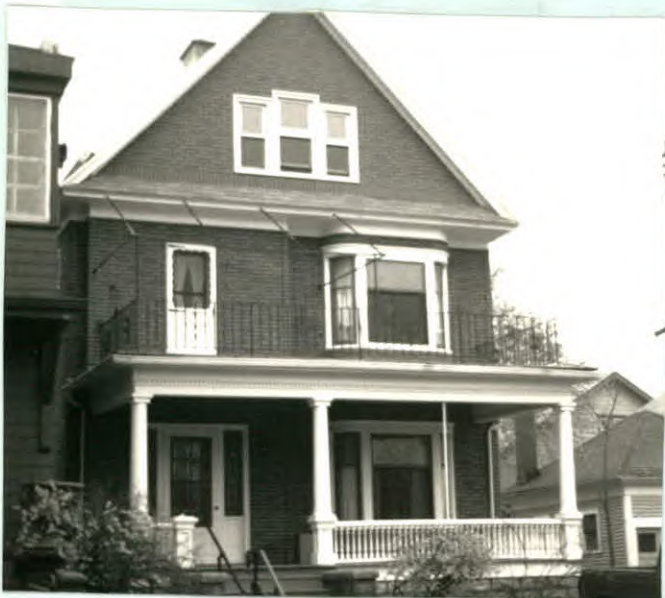
12. PHOTO: 37-19a

Two and a half story frame with front facing gable roof. Full-width flat roof porch. Rough cut, regular course stone base. Doric columns support entablature with dentils. Extending cornice. Spindle balustrade. Glass paneled door with 3/4 length leaded glass sidelights. Bowed first floor bay. Single-hung windows with leaded top lights. Second floor left side boxed bay has two-light porch

ARCHITECT: bay has single-hung windows with leaded top lights. Band of trim below gable eave. Pedimented gable door. Right side bowed
 BUILDER: has tri-part window. Center 1/1 window flanked by smaller 1/1 windows.
