BUILDING-STRUCTURE INVENTORY FORM

* * * * * * * * * * * * * * * * * * * *
IDENTIFICATION
1. BUILDING NAME (S):
2. COUNTY: Erie TOWN/CITY: Buffalo VILLAGE:
2 STREET LOCATION: 2194 Main St
3. STREET LOCATION: 2194 Main St 4. OWNERSHIP: a. public b. private 4.
5 PRECENT OWNER. John O'Hara ADDRESS. 2194 Main Street

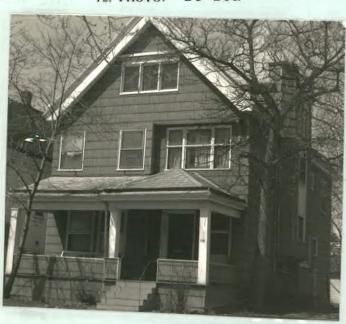
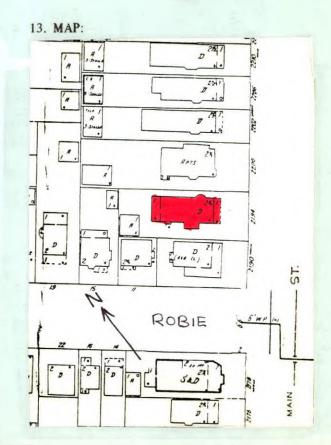
12. РНОТО: 28-28а

e. other
0. CONDITION: a. excellent □ b. good ☒ c. fair □ d. deteriorated □
1. INTEGRITY: a. original site ☒ b. moved ☐ if so,when?
c. list major alterations and dates (if known):
Remodeled into 3 family in 1944

18. OTHER NOTABLE FEATURES OF BUILDING AND SITE (including interior features if known): Two and a half story frame with front facing gable roof with bargeboard. Full-width porch has shed roof with hip roof projection over entrance. Square doric supports. Asphalt shingled rail. Glass and wood paneled door flanked on one side by double hung 1/1 window. First floor has two 1/1 windows. SIGNIFICANCE Second floor right end bay, recessed, has three-part

19. DATE OF INITIAL CONSTRUCTION: c. 1890 window, 1/1 lights. Two double hung 1/1 windows on second floor. Gable has
three windows, single light with diamond patterned tracery. Entablature window head.
