BUILDING-STRUCTURE INVENTORY FORM

DIVISION FOR HISTORIC PRESERVATION
NEW YORK STATE PARKS AND RECREATION
ALBANY, NEW YORK (518) 474-0479

- BUILDING NAME(S): _____
- COUNTY: Erie TOWN/CITY: Buffalo VILLAGE: _____
- STREET LOCATION: 42 Willow Lawn
- OWNERSHIP: a. public b. private
- PRESENT OWNER: Edward O'Connor ADDRESS: 42 Willow Lawn
- USE: Original: Residential Present: Residential
- ACCESSIBILITY TO PUBLIC: Exterior visible from public road: Yes No
Interior accessible: Explain by permission

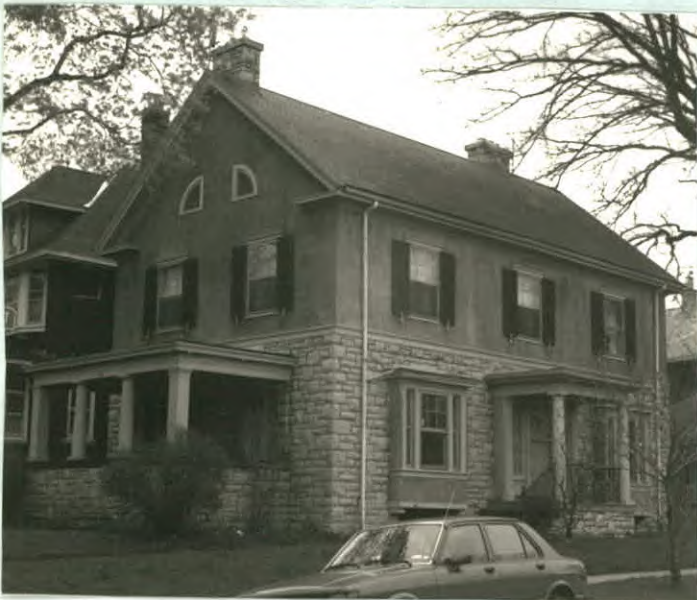
12. PHOTO: 39-23a

Two and a half story Colonial Revival style. Side gable roof with cornice end returns. Symmetrical facade. Rough cut, irregular course stone first floor. Partial-width flat roof porch. Doric columns support entablature. Triglyphs and guttae decorate frieze. Wood paneled door with leaded sidelights. End bays first floor have boxed bay windows. Flat roof with extending cornice. Center double-hung 6/1 window with slender 2/1 side windows. Stucco second

19. DATE OF INITIAL CONSTRUCTION: 1911
 ARCHITECT: double hung 6/1 windows. Cornice window head.
Louvred window shutters. North side has full-width
 BUILDER: flat roof porch. End square Doric supports with Doric
columns. Lighted double sash doors. Second floor 6/1
windows. Cornice window head.
