**BUILDING-STRUCTURE INVENTORY FORM**

1. BUILDING NAME(S): \_\_\_\_\_
2. COUNTY: Erie TOWN/CITY: Buffalo VILLAGE: \_\_\_\_\_
3. STREET LOCATION: 2210 Main St
4. OWNERSHIP: a. public  b. private
5. PRESENT OWNER: Carl Ruehl ADDRESS: 2210 Main Street
6. USE: Original: Residential Present: Residential
7. ACCESSIBILITY TO PUBLIC: Exterior visible from public road: Yes  No   
 Interior accessible: Explain by permission

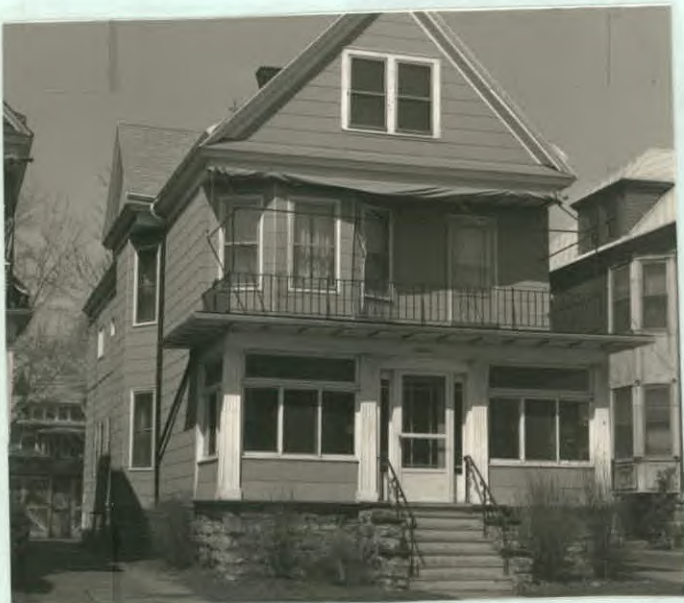
12. PHOTO: 28-33a

Two and a half story with front facing gable roof. Full-width flat roof enclosed porch. Extending eaves with modillions. Glass paneled door with lighted border. Sidelights. Tapered Doric pilasters, with capital elaboration, flank window bays. Three single light windows with transom. Second floor has semi-hexagonal bay, double hung windows, l/l lights. Glass paneled porch door. Pedimented
